CIMAC
CONGRESS
HELSINKI | JUNE 6–10, 2016

2016 | 067

Interaction between ship operation and cylinder lubrication of marine two-stroke diesel engines

Markus Weber, Winterthur Gas & Diesel Ltd.

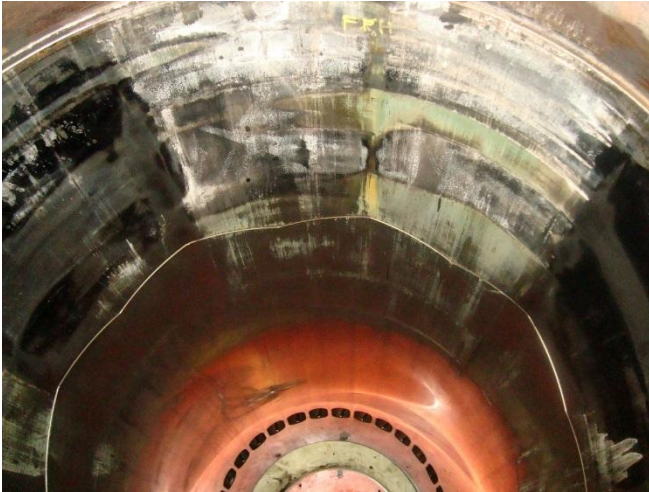
Picture 1: Cylinder liner surface with signs of extreme corrosive attack

In the very beginning of the upcoming issue of slow-steaming after the initiation of world's financial crisis at the end of 2008, it appeared that corrosion of cylinder liner running surface might be caused by the lower surface temperatures of cylinder liner as a result of lower engine operating load, as such cases had been observed relatively rarely in earlier times. Picture 1 shows a cylinder liner with such a pronounced corrosive running surface, whereas Picture 2 represents a case with regular surface condition.

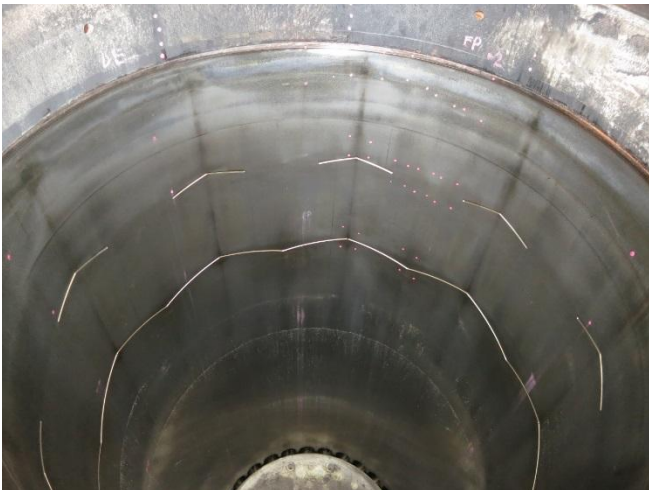
Picture 2: Cylinder liner surface with regular running surface appearance

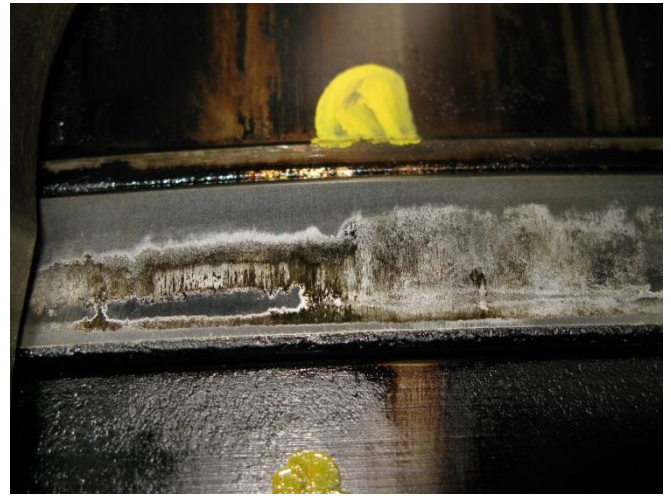
Picture 3: Piston ring running surface with signs of extreme corrosive attack

The appearance of some piston ring running surfaces was so severe that it was hard to believe, corrosion could yield such extensive damages on the coating of piston rings as can be seen from Picture 3. However, the later described investigation on piston ring coating demonstrated that such damage can very well be caused by exposure of the piston ring running surface

Benchmark for piston ring coating resistance against sulphuric acid corrosion - The extraordinarily abnormal appearance of piston rings suffering from slow-steaming conditions as shown in Picture 3 was the incentive to study, if CKS 37 is the optimal coating when it comes to sulphuric acid attack and therefore the appropriate choice for slow-steaming operation. Such coating is state of the art since decades for car and heavy duty applications and its capabilities regarding resistance against sulphuric acid were challenged by the plasma-sprayed coating PM2. The test set-up was such that the samples were exposed to diluted sulphuric acid and a potential difference was applied in between the sample and the solution in order to avoid the build-up of the chemically very stable Chromium oxide layer that forms on the surface of CKS 37 otherwise. A part of that sample was masked to generate a reference surface, where no dissolution of the coating took place during the test, unlike the PM2 sample.

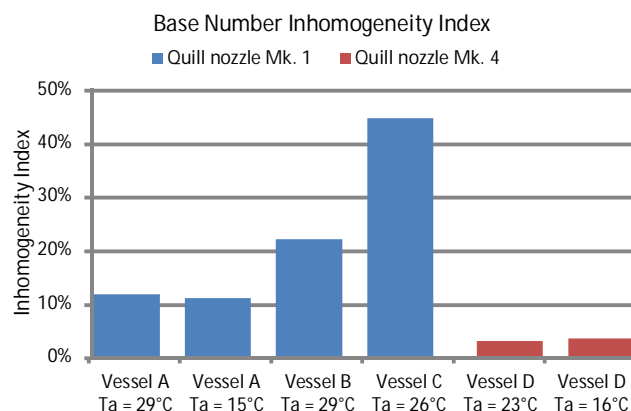
Figure 3: Inhomogeneity Index for RPSS samples taken aboard of four different vessels under various ambient conditions with two different cylinder lubrication quill types (T_a = ambient temperature)

This index can be applied to any simultaneously measured property of lubricant samples and shall be minimal for best homogeneity, which means that the samples are chemically close to identical, indicating a nearly perfect lubricant distribution in circumferential direction. Thanks to the normalisation applied, indexes from different engines, loading conditions, lubricants, lubrication systems, etc. can be compared without further measures. Figure 3 shows a comparison of Inhomogeneity Indexes from RPSS measurements taken on four different engines (vessels) with varying ambient conditions, having two different set-ups for cylinder lubricant distribution quills. The data shows a significant difference between quill nozzle Mk.1 and quill nozzle Mk.4. As quill nozzle Mk.4 has rather low Inhomogeneity Index values compared to Mk.1, it is concluded that the lubricant distribution with regard to BN is rather equal over the entire circumference for that quill type and is therefore the preferred design solution.

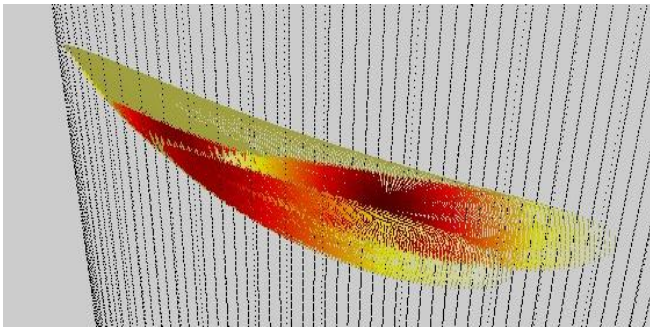
Figure 5: Output of simulation software for optimising cylinder lubrication quill nozzle geometry

impingement of lubricant on the cylinder liner wall of a multiple-hole lubrication quill nozzle. The software allows to quantitatively compare the distribution and impingement area of various combinations of parameters in order to optimise the quill geometry for both high-load and slow-steaming engine operation. The parameters of variation in the software are the same as mentioned above for the test cell shown in Figure 4. The cylinder lubrication quills for Wärtsilä X-type engines are laid out using this tool, where an example output can be seen in Figure 5.

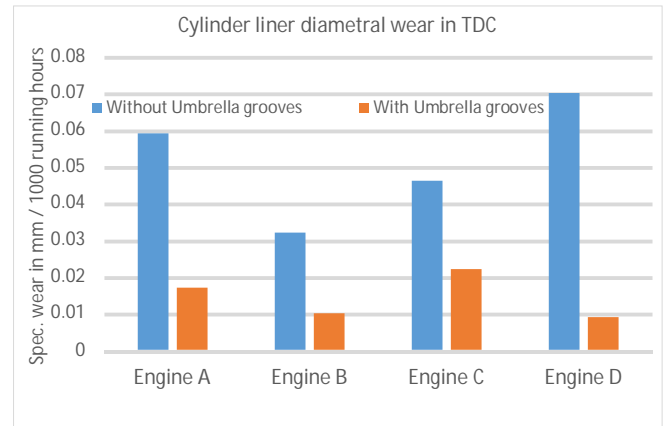
Figure 7: Evaluation of test results using liners with and without "Umbrella grooves" for several engine types having different configurations of piston rings and cylinder lubrication systems

The results presented in Figure 7 indicate a significant reduction of cylinder liner wear in TDC position by application of "Umbrella grooves" for oil distribution above to lubrication quills on the cylinder liner wall.

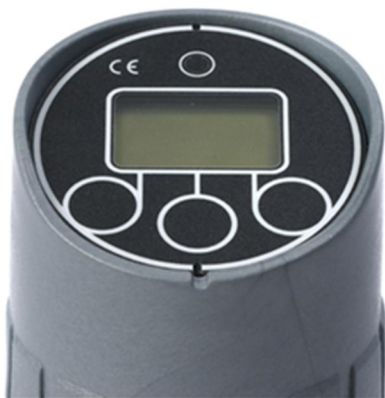
Picture 8: Shaker kit for BN measurement

However, for an optimised engine operation as given above, measurement of BN must be carried out on board vessel. The industry has developed two types of measurement instruments for this purpose, the so-called shaker kit, as an example of many choices available can be seen in Picture 8, and the portable infrared spectrometer, as can be seen in Picture 9.

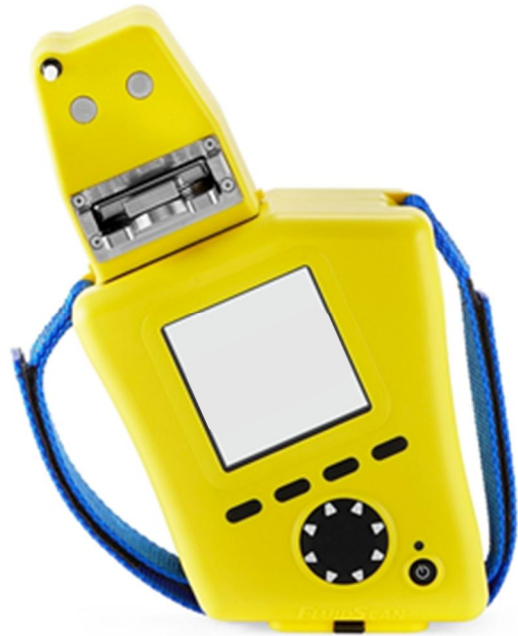
Picture 9: Infrared-spectrometer for BN measurement

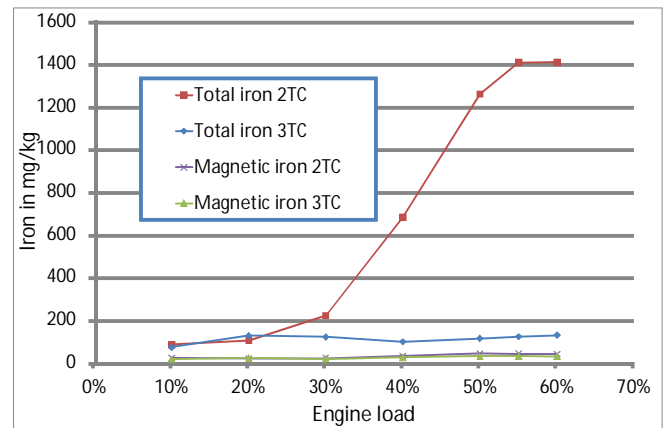
Figure 10: Comparison of PUS drain oil analysis for slow-steaming engine operation, once with all turbochargers and once with one turbocharger switched off

Such effect can be indirectly proven by analysing drain oil from piston underside space as follows: the total amount of iron in a sample is measured by using ICP-AES. Abrasive and therefore magnetisable iron is measured with a so-called Particle Quantifier (PQ). The difference between the ICP-AES value and the PQ index of one particular sample represents corrosive wear. If a series of samples has been taken under comparable conditions and the samples have been analysed by the same lab with the same analysis equipment, it is possible to make comparisons between those samples as can be seen in Figure 10.

To quantify this effect and to evaluate according countermeasures, a field study was carried out. An engine equipped with two regular turbochargers and one turbocharger that could be switched on and off by means of a set of valves was run at several loads once with all turbochargers in operation and once with one turbocharger switched off up to the speed limit of the turbochargers. The results were such as can be seen in Figure 10 that for operation with one turbocharger switched off, corrosive wear of cylinder liner material increased significantly, whenever engine load was above a certain limit. This limit is assumed to be the moment, when scavenging ratio goes below 1, i.e. not enough volume flow is available from the turbochargers to flush the liner completely with fresh air and more exhaust gas remains in the combustion chamber than normal.
