Guide for judging condition of relevant piston-running components

LINERS, PISTONS AND PISTON RINGS
Version 5.0 April 2021

WIN GD

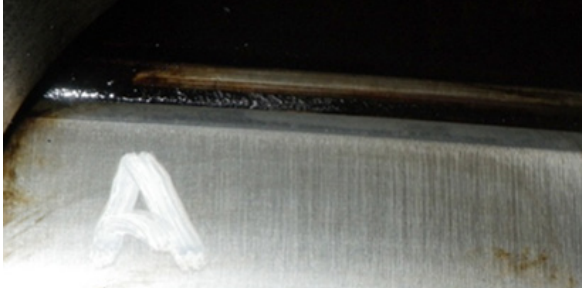
Ring type: SCP1CC20, A ring
Condition: Abrasion (3 body abrasion) can be caused by catalyst fines in fuel oil, or foreign hard particles (e.g. sand in intake air).
Acceptance: Acceptable
Action: See technical bulletin RT-140

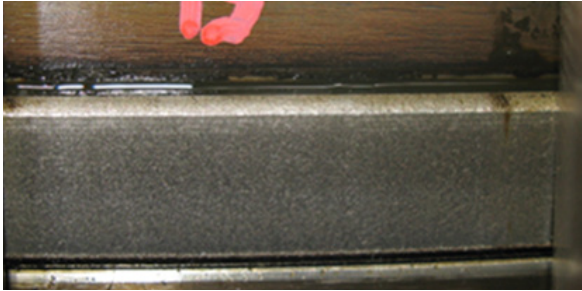
Ring type: SCP1RC16, B ring
Condition: RC running-in coating in spotless condition
Acceptance: Acceptable
Action: No action required

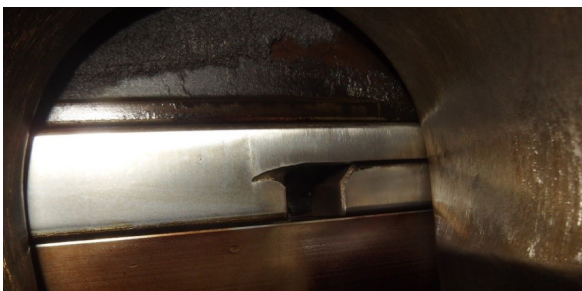
Ring type: GTP1CC24
Condition: Erosion at GT ring gap by combustion gases
Acceptance: Normal
Action: No action required

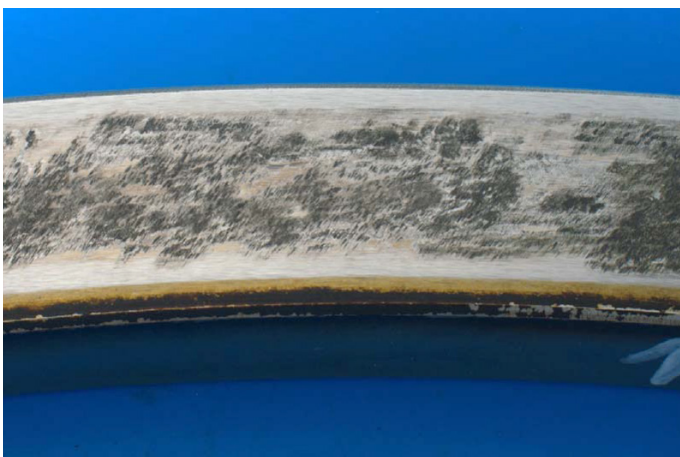
Ring type: GTP1CF24, A ring
Condition: Bottom face Cr coating fretting
Acceptance: Acceptable
Action: No action required

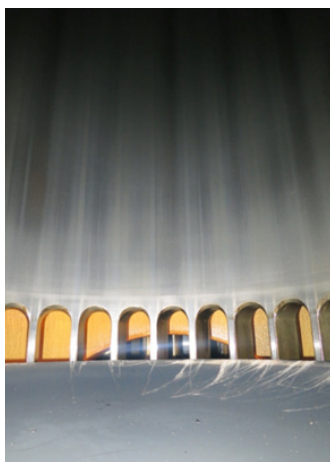
Condition: Good liner condition, smooth and homogenous liner appearance, honing marks not visible anymore
Acceptance: Normal
Action: No action required

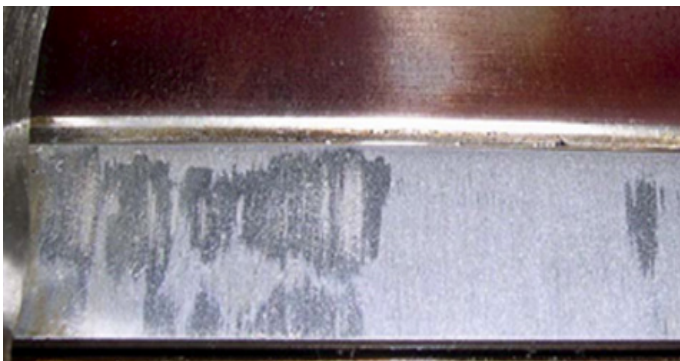
Ring type: SCP1RC20, B ring
Condition: Hard contact marks, RC coating gone, ring running on base material
Acceptance: To be monitored. Piston ring may recover
Action: Check entire ring surface. Temporary increase of set feed rate by 0.2 g/kWh and if possible reduce injection correction factor in flexView or UNIC to 80% or install spacer in fuel pump for RTA engines. Consider exhaust gas deviation alarm.

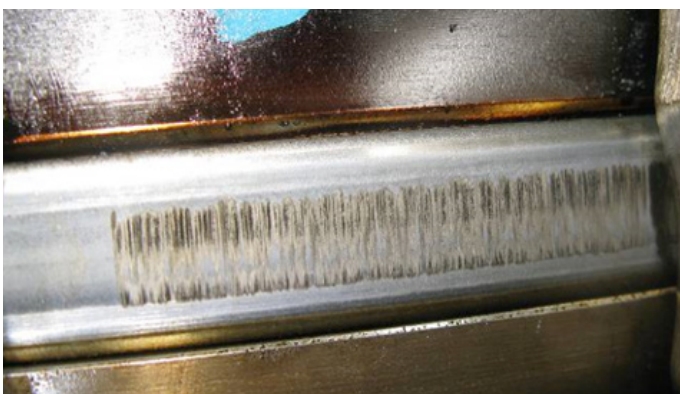
Ring type: SCP1CC20, B ring
Condition: Scoring marks
Acceptance: To be monitored. Piston rings may recover
Action: Check entire ring surface. Temporary increase of set feed rate by 0.2 g/kWh and if possible reduce injection correction factor in flexView or UNIC to 80% or install spacer in fuel pump for RTA engines. Consider exhaust gas deviation alarm.

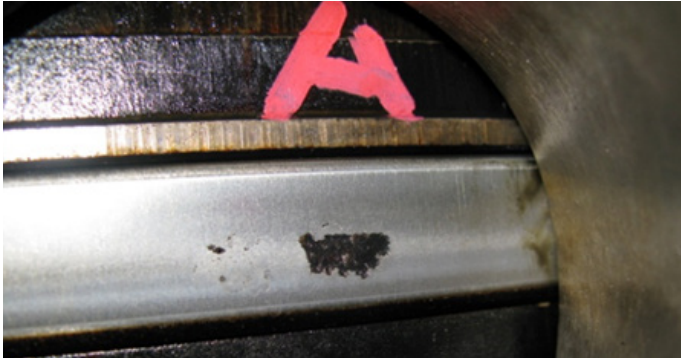
Ring type: SCP1CC20, A ring
Condition: Cracked CC coating and spalling
Acceptance: To be monitored. Limited size of spalling
Action: Check entire ring surface. In case spalling is less than 20 mm in length and less than half of the ring height the condition is still acceptable

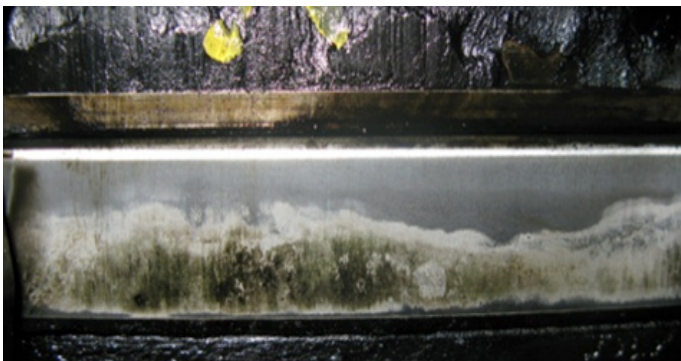
Ring type: SCP1CC20, A ring
Condition: Ring with severe corrosion spots
Acceptance: To be monitored. Corrosion may result in high wear on ring and liner
Action: Check correct cylinder oil feed rate setting. Check residual BN in piston underside drain oil. Check remaining CC coating thickness.

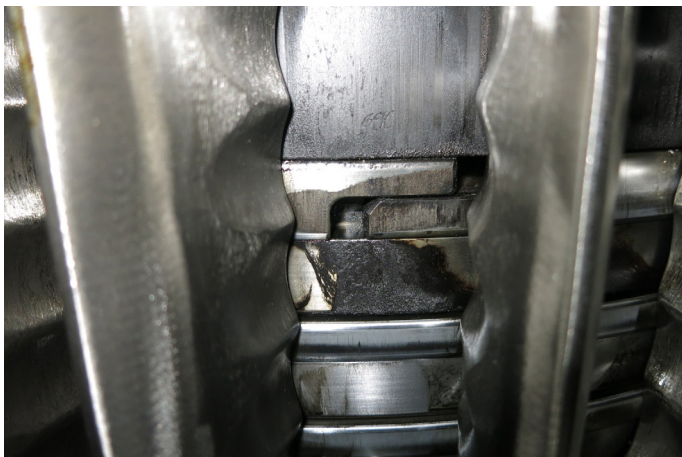
Ring type: GTP1CC20, A-ring
Condition: Local scoring / scuffing of ring gap ends
Acceptance: Critical, to be monitored very closely.
Action: Local dressing up of ring end gaps with emery cloth (80 grain size) through scavenging air ports. If condition deteriorates, then piston ring to be replaced and scorings on liner to be dressed up

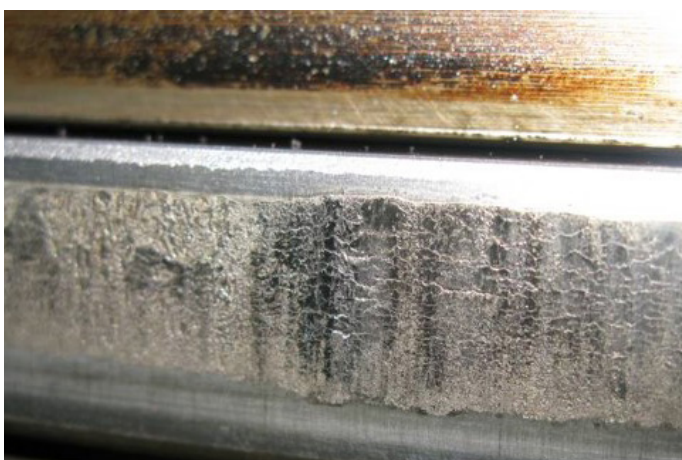
Ring type: SCP1CC20
Condition: Active scuffing, CC coating destroyed, active scuffing
Acceptance: Critical condition
Action: Unit to be overhauled. Temporary increase of set cylinder oil feed rate by ~0.2 g/kWh and reduce injection correction factor in flexView or UNIC to 80% or install spacer in fuel pump for RTA engines until unit is overhauled. Consider exhaust gas deviation alarm. If ships schedule permits it, switch off the unit, till unit is overhauled.

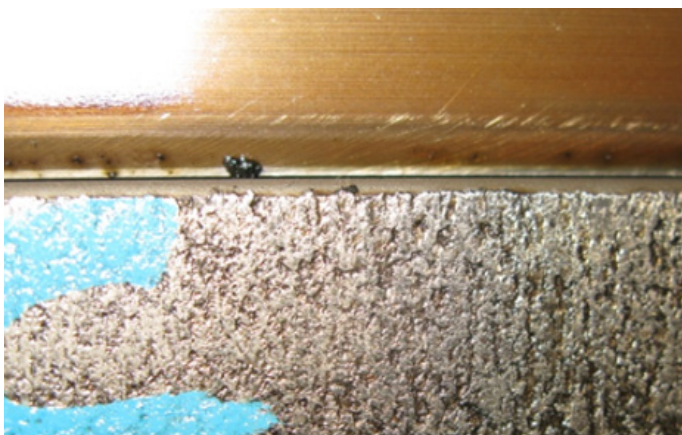
Ring type: SCP2CC20, C ring
Condition: Scuffed with some CC remaining active scuffing
Acceptance: Critical condition
Action: Unit to be overhauled. Temporary increase of set cylinder oil feed rate by ~0.2 g/kWh and reduce injection correction factor in flexView or UNIC to 80% or install spacer in fuel pump for RTA engines until unit is overhauled. Consider exhaust gas deviation alarm. If ships schedule permits it, switch off the unit, till unit is overhauled.

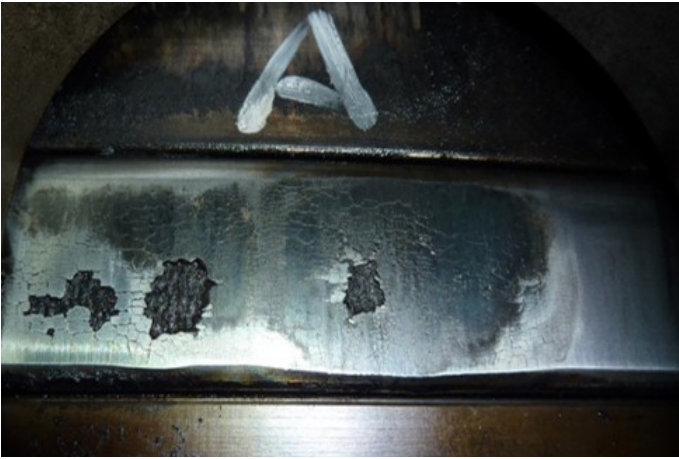
Ring type: GTP1CF24, A ring
Condition: Locally scuffed, CC coating destroyed and spalling, scuffing not active
Acceptance: Critical condition
Action: Unit to be overhauled. Temporary increase of set cylinder oil feed rate by ~0.2 g/kWh and reduce injection correction factor in flexView or UNIC to 80% or install spacer in fuel pump for RTA engines until unit is overhauled. Consider exhaust gas deviation alarm

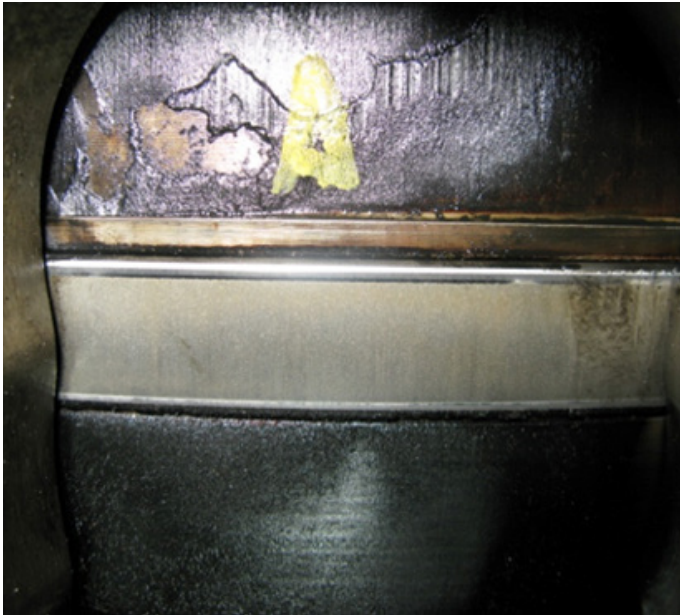
Ring type: SCP1CC20, A ring
Condition: Completely worn CC coating
Acceptance: Critical condition, further operation of such rings will result in a greater liner wear and increased risk for scuffing.
Action: Unit to be overhauled

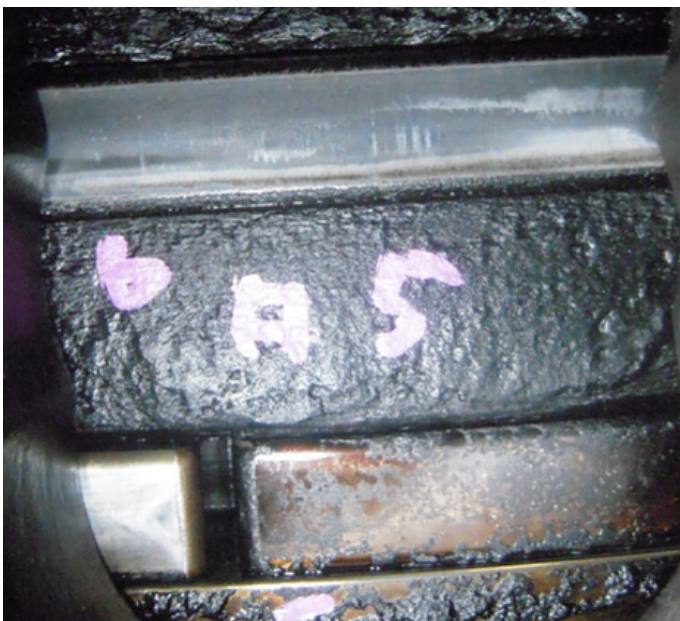
Ring type: SCP1CC20, A and B ring
Condition: A ring with some corrosion, B ring lost tension, with excessive deposits, cylinder oil feed rate, BN and fuel oil sulphur content not matching
Acceptance: Critical condition
Action: Unit to be overhauled. Check correct cylinder oil feed rate setting. Check residual BN in piston underside drain oil.

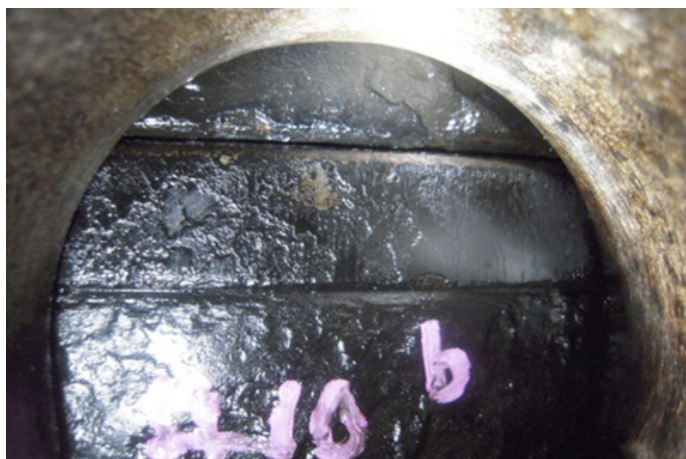
Ring type: SCP1CC20, A ring
Condition: Ring collapsed, with excessive deposit
Acceptance: Critical condition
Action: Unit to be overhauled. Switch-off unit

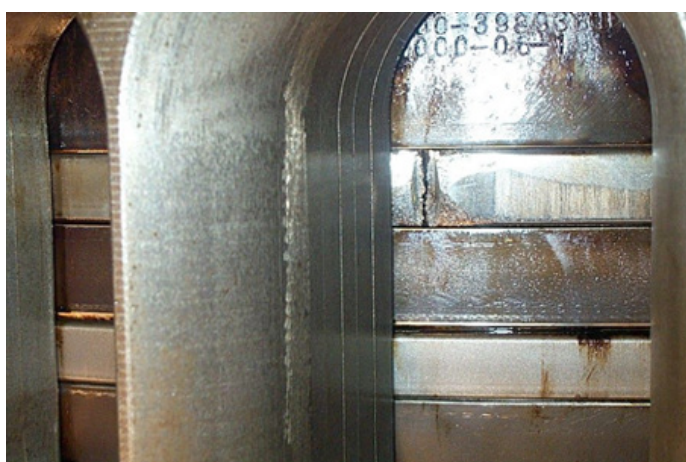
Ring type: SCP1CC20, A ring
Condition: Ring broken
Acceptance: Critical condition
Action: Unit to be overhauled. Switch-off unit

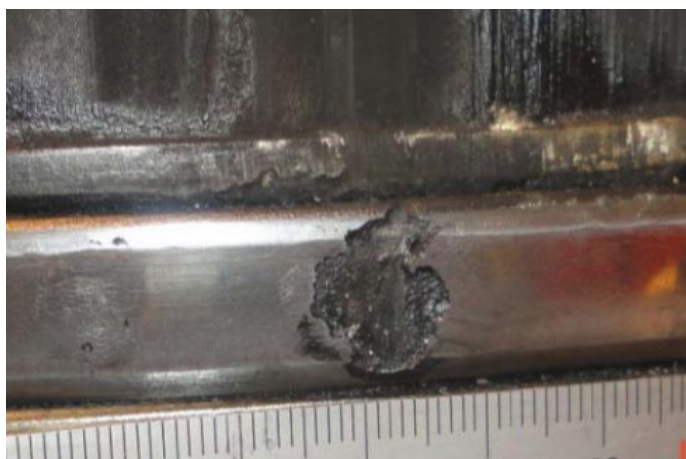
Ring type: SCP1CC16, A ring
Condition: A ring with excessive spalling across full ring height
Acceptance: Critical condition
Action: Unit to be overhauled. Temporary increase of set cylinder oil feed rate by ~0.2 g/kWh and reduce injection correction factor in flexView or UNIC to 80% or install spacer in fuel pump for RTA engines until unit is overhauled. Consider exhaust gas deviation alarm

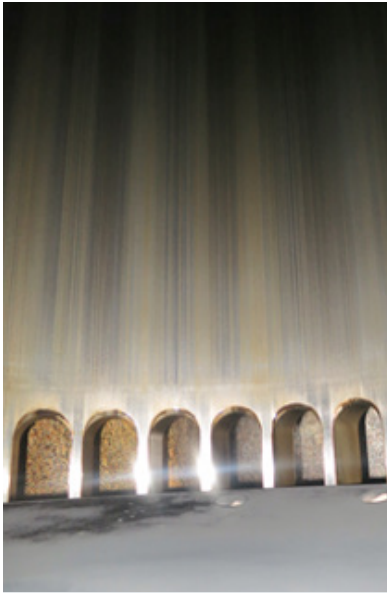
Condition: Cylinder liner with scoring marks
Acceptance: Critical condition
Action: Depending on piston ring condition unit should be overhauled and liner re-honed. If piston rings are in spotless condition, the unit can be kept in operation

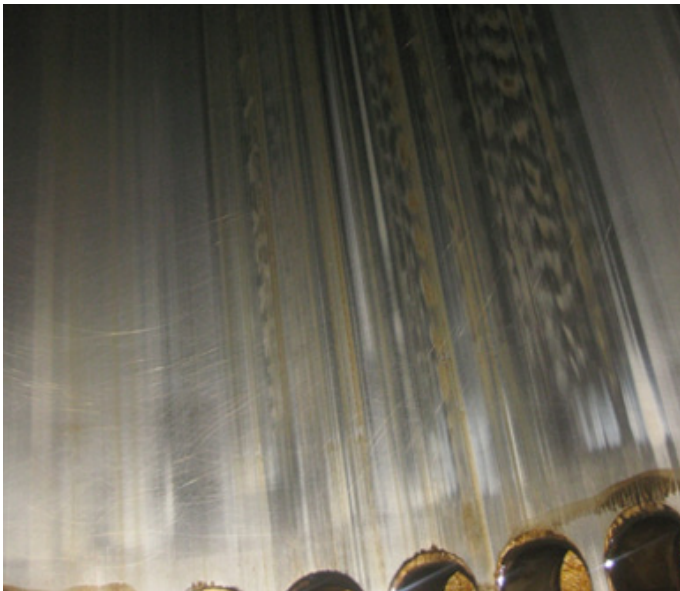
Condition: Liner with local scoring and scuffing marks
Acceptance: Critical condition
Action: Depending on piston ring condition unit should be overhauled and liner dressed-up or re-honed. If piston rings are in spotless condition, the unit can be kept in operation

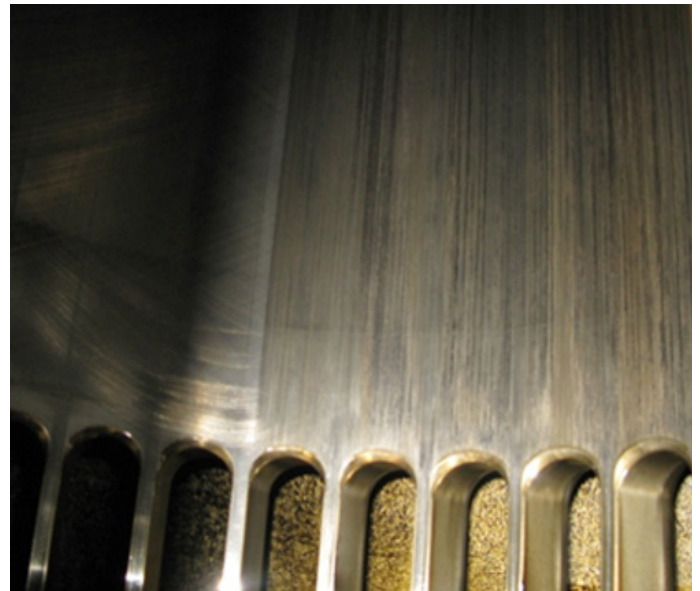
Condition: Scuffing marks on liner
Acceptance: Critical condition
Action: Unit to be overhauled. Local scoring and scuffing marks are to be dressed up or re-honed

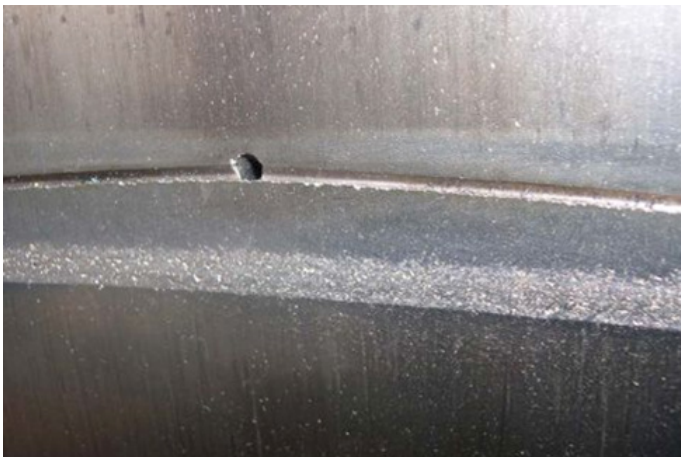
Condition: Scuffed liner with wear step in the region of the liner grooves

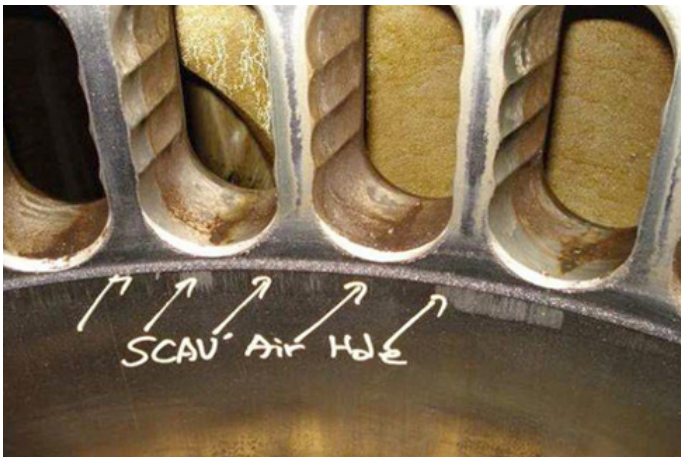
Condition: Scuffed liner with wear step in the region of the scavenging ports

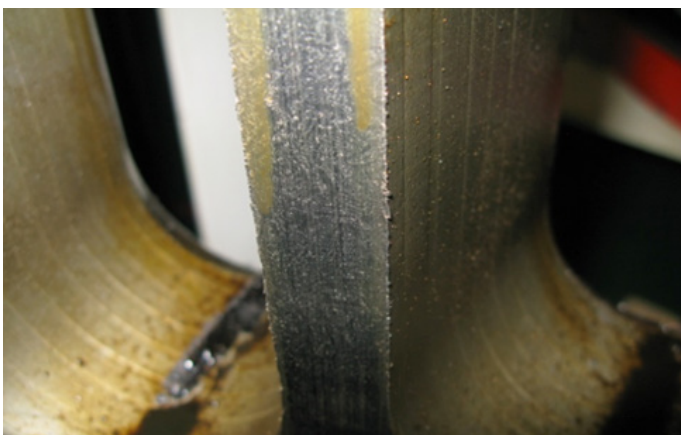
Condition: Scuffed liner with burrs on the edges of the scavenging air ports

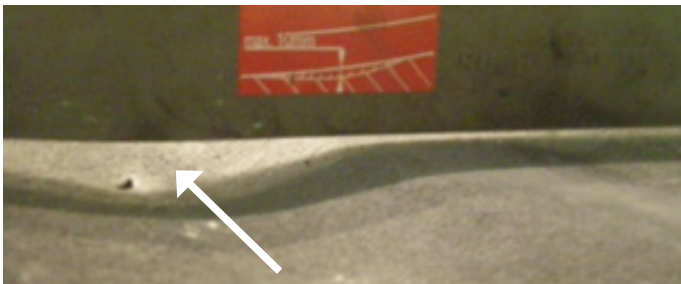
Condition: Excessive loss of material, above wear limit. See arrow, clearance between template 94366 and piston
Acceptance: Critical condition
Action: Piston to be replaced

The top of piston land is to be checked with tool template 94366a to estimate the loss of material. Wear limits please refer to MM 3403-4.

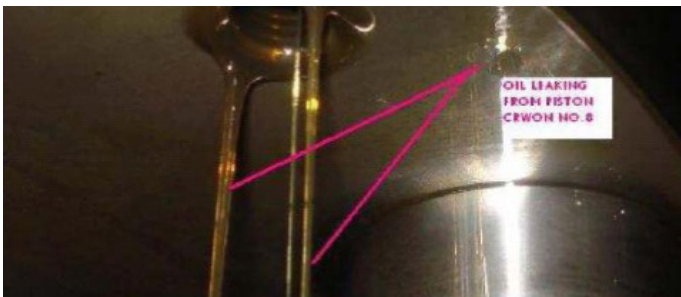
Condition: Piston cooling oil leakage caused by defective o-ring in piston crown
Acceptance: Critical condition
Action: Source of oil leak to be found and rectified

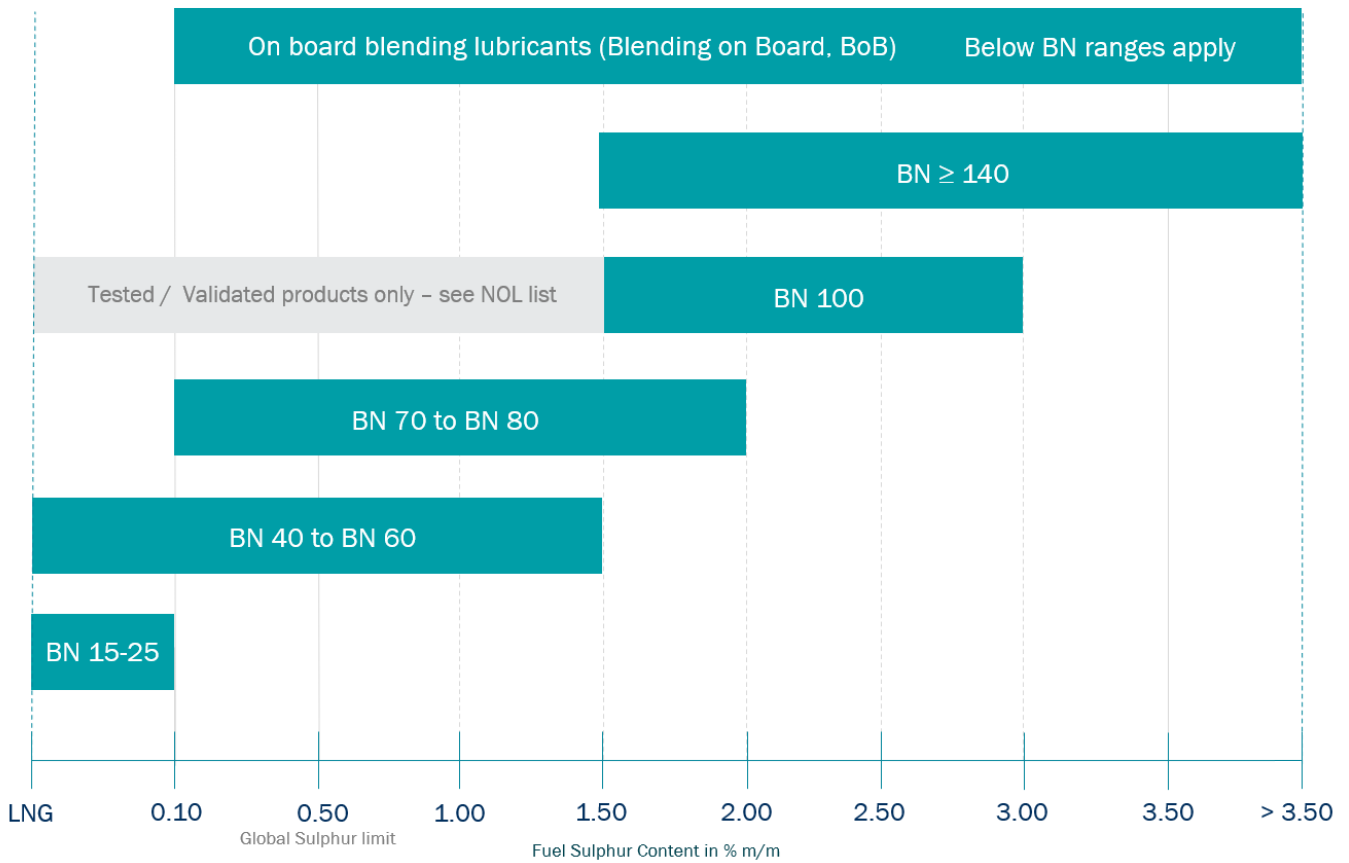
The selection of the correct BN of the cylinder lubrication oil must be driven by the results from piston underside drain oil analysis. However, as a general guidance for suitable combinations, the following figure shows starting points for the optimization process and recommendations if piston underside drain oil monitoring is not done.
