Winterthur Gas & Diesel

W-X92

The most efficient Engine for large Container Vessels

W-X92, June 2016 / H. Brunner, J.-N. Constantin, L. Knipstrom

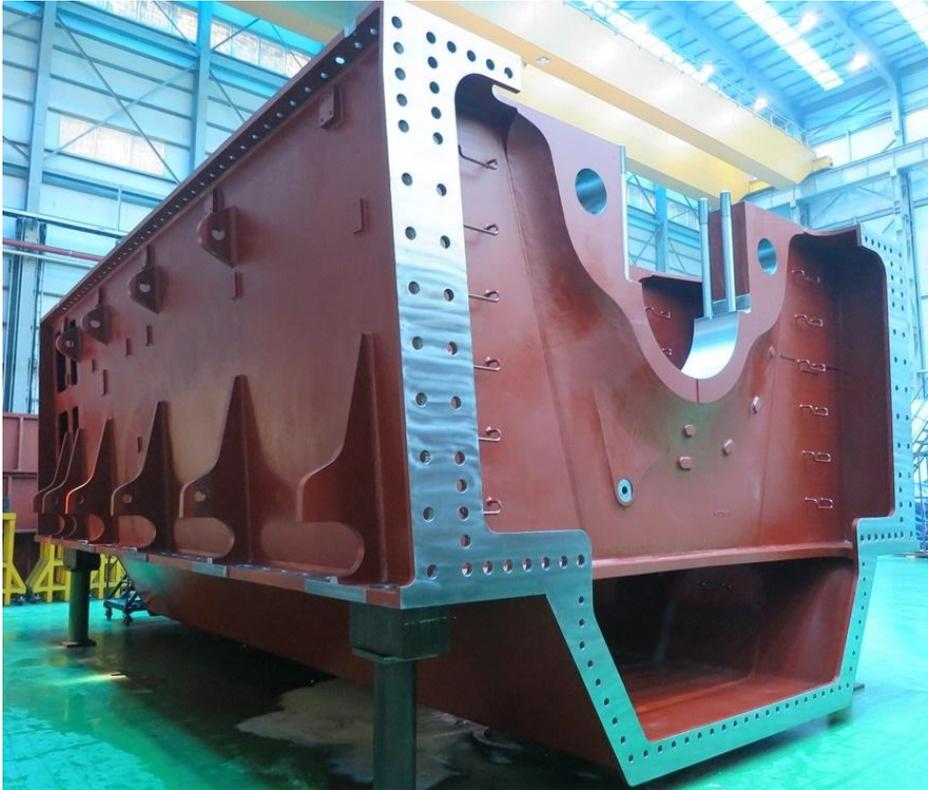
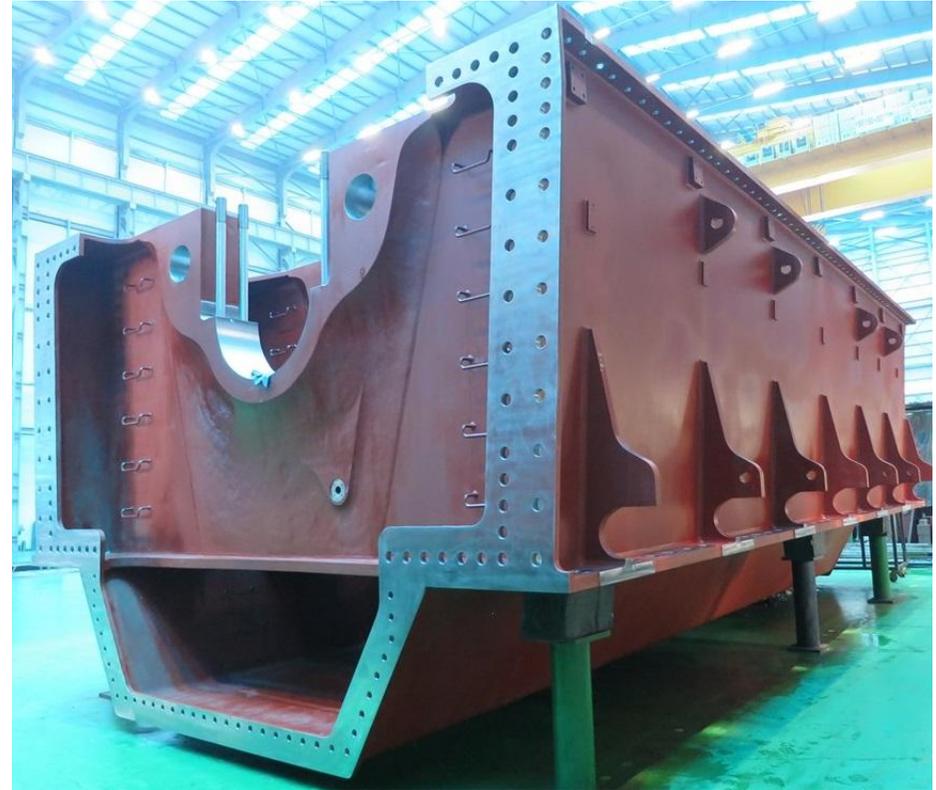
W10X92 Bedplate

- *Bedplate*

*Compact single wall design,
Integrated thrust bearing*

- *Optimized for low deformations by propeller thrust force*

Driving End

Free End

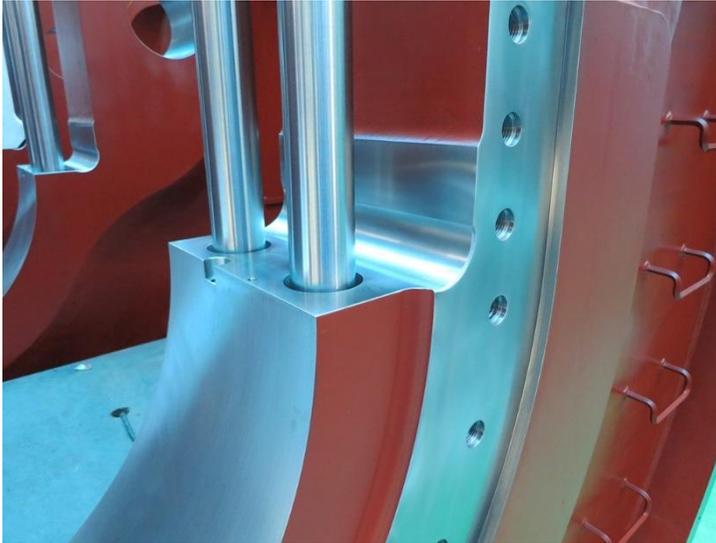
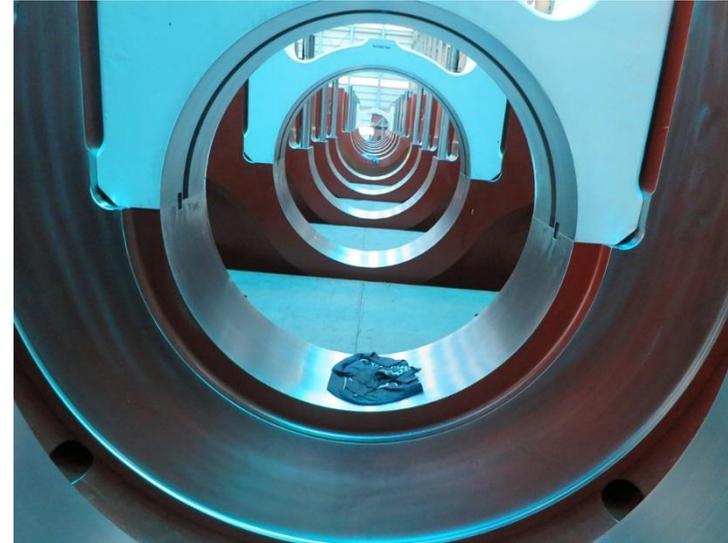
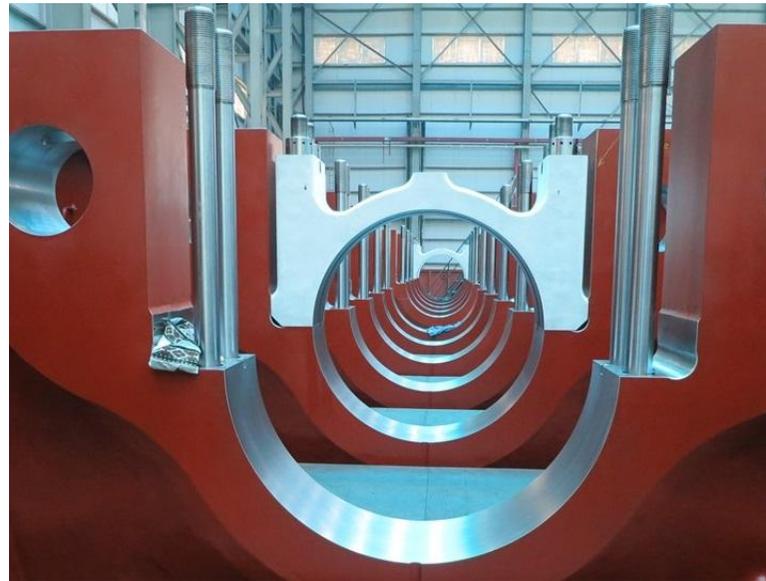
W-X92 – Main Bearing

- *Main bearings*

*Two thin shell bearing design
with thick white metal layer*

Two bearing diameters (FE < DE)

Layout by Elasto Hydro

Dynamic calculation

- What should be avoided
 - Main engine breakdown
 - Contact between crankshaft and back metal of main bearing shell
- Preventive measure
 - White metal layer thicker than bending of crankshaft
- Service experience
 - No main engine breakdown after a main bearing failure in Wärtsilä engines
 - Extreme low risk to damage the crankshaft journal
 - Main bearing shell exchanged at next port and trip continued
 - Proven design

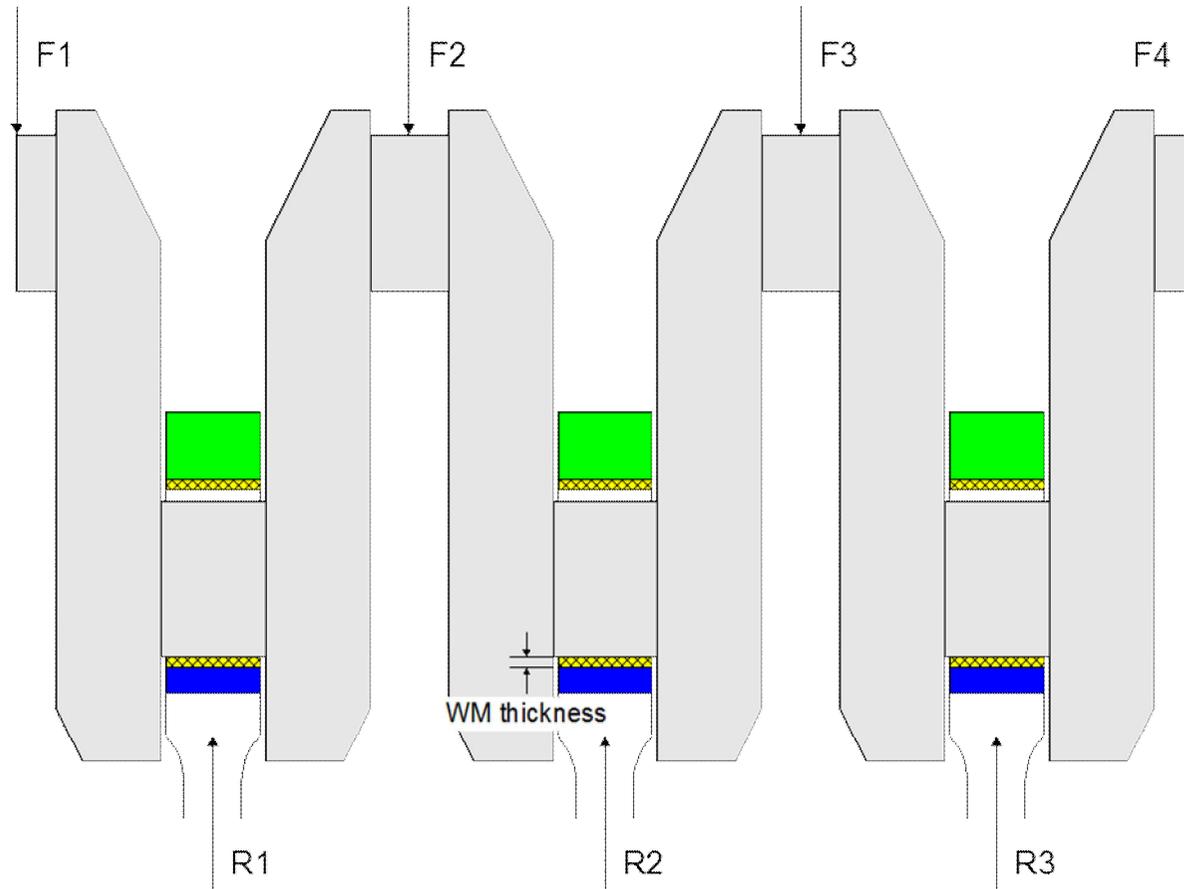
Crankshaft with main bearings

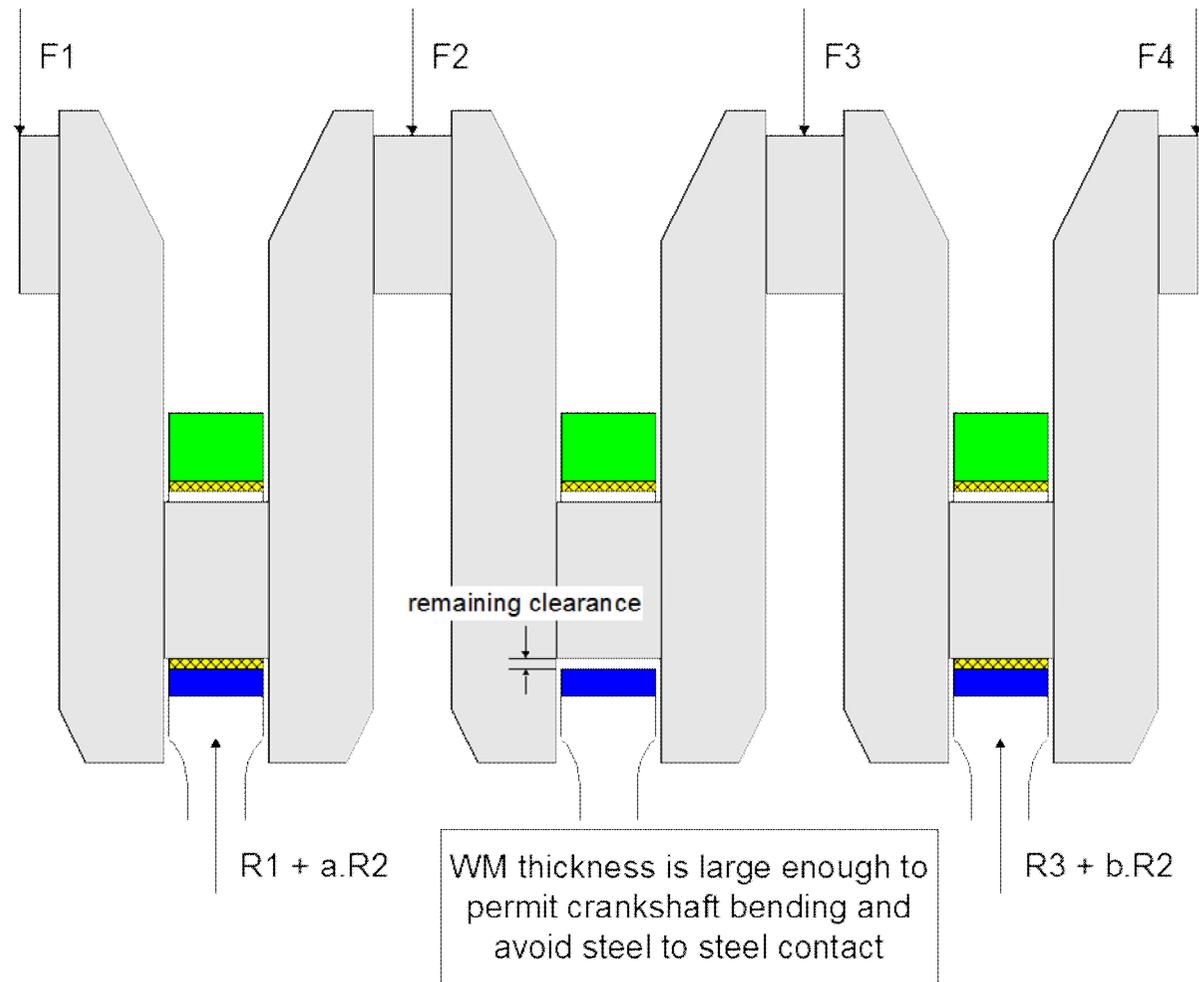
One main bearing shell without white metal

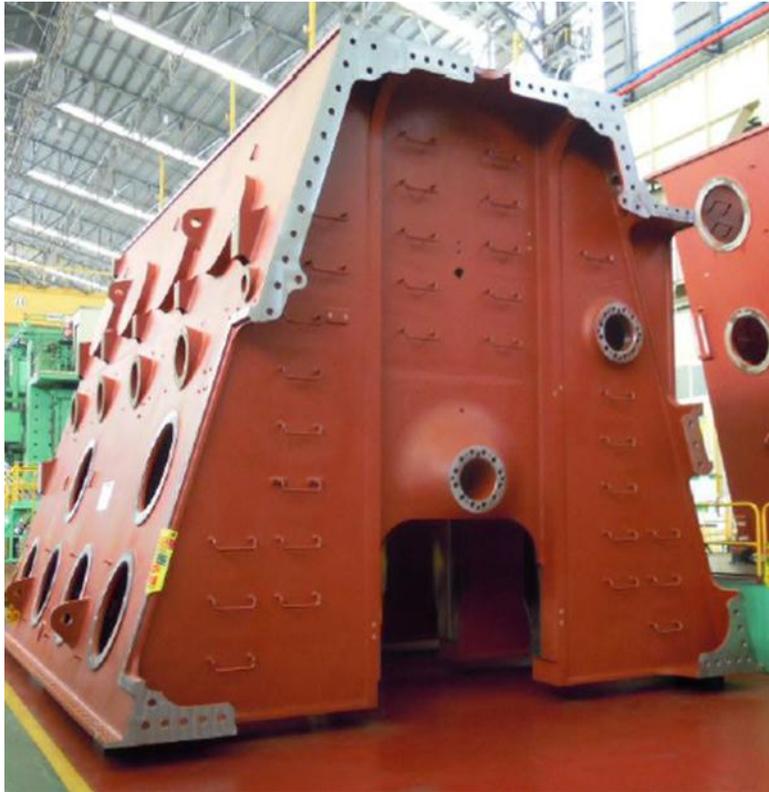
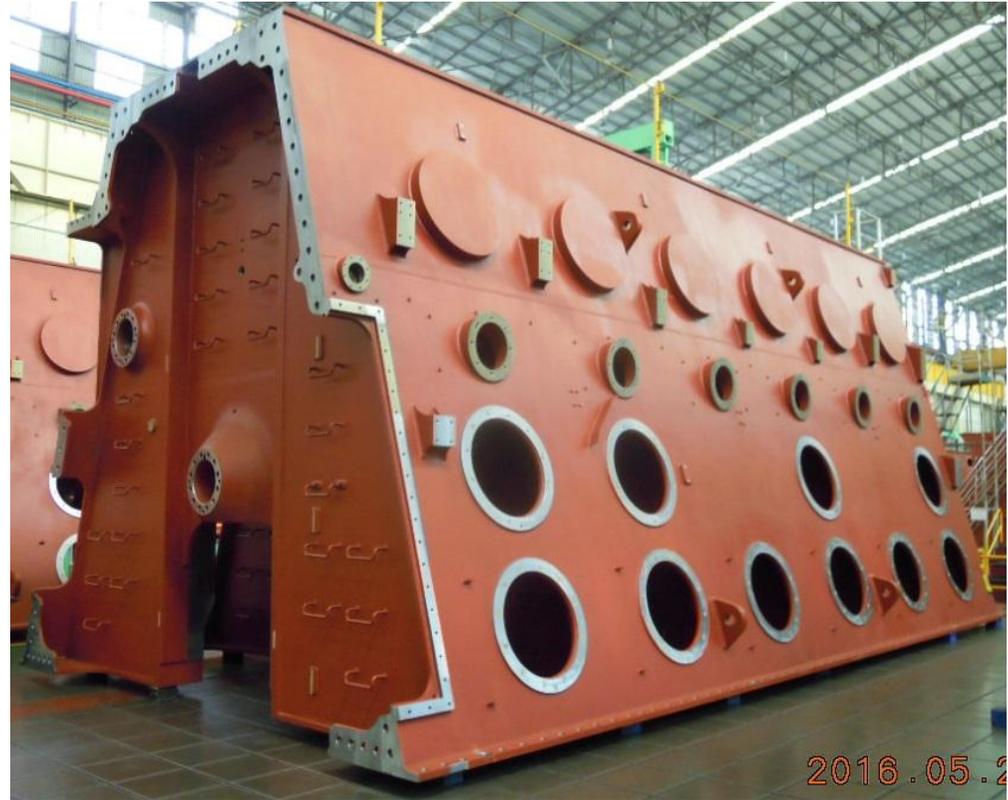
W10X92 Column

- *Column*

Sturdy double wall design

Same concept as on W-X62/72

Mid-sheets are executed as single walls

Thick guide rails to reduce deformation and stress under guide shoe forces

Design optimised for ease of manufacturing and allowing strong quality assurance

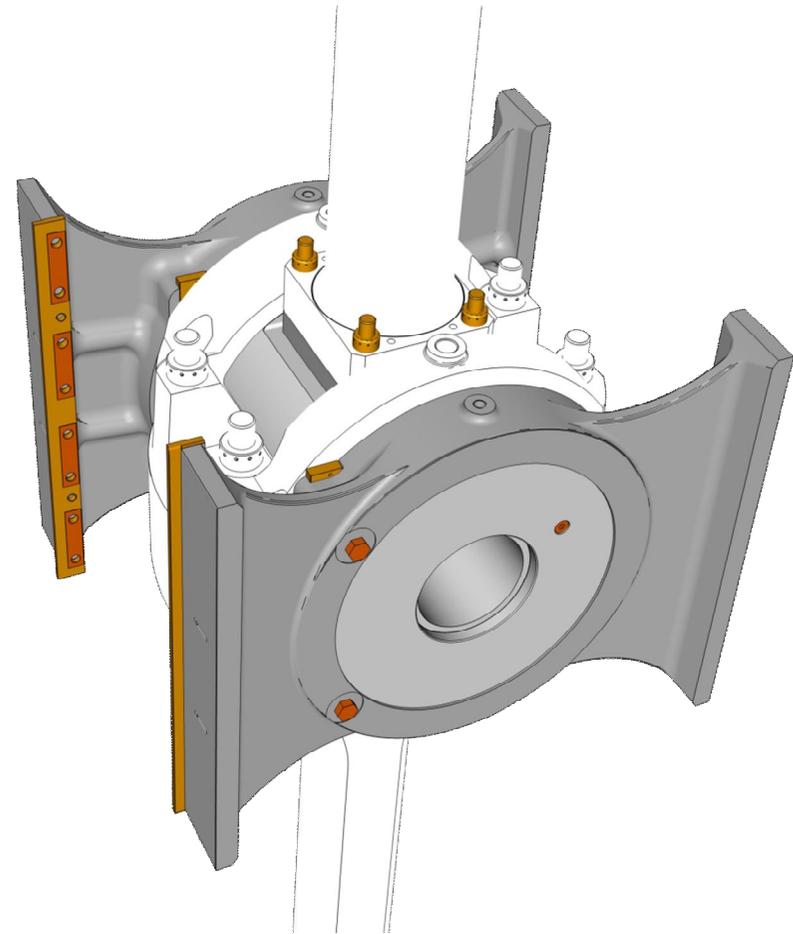
- *Crosshead*
Guide shoe in one piece (steel cast) with white-metal lining
Optimized force transmission for lowest load on engine structure
Large contact surface between guide shoe and guide rail at bottom dead centre
Design similar to W-X62/72/82

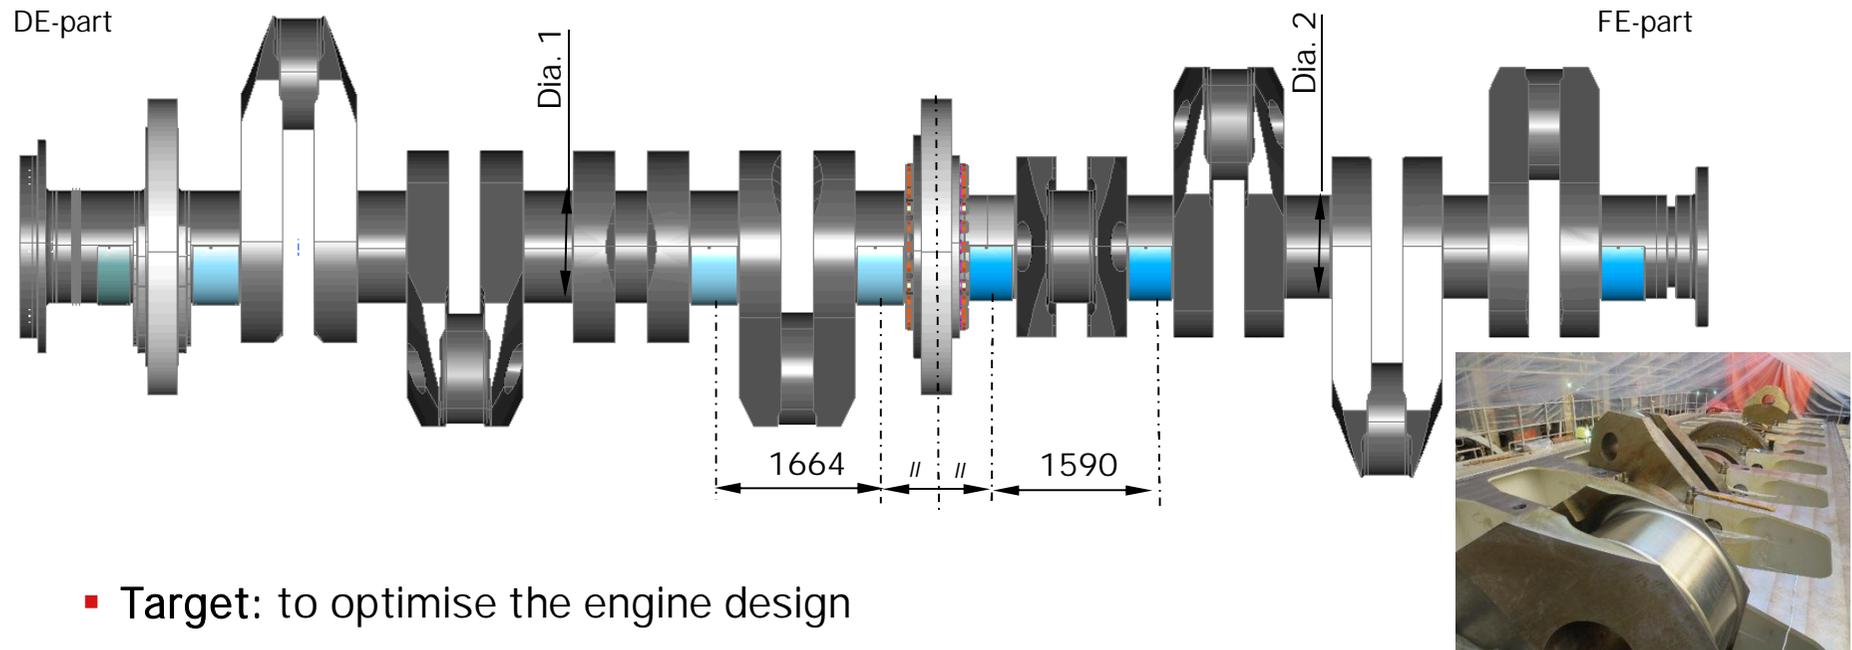
- Target: to optimise the engine design
- Feasibility: the FE part of crankshaft carries less torque and can be optimised
- Design: Different cyl. distance for DE (1664mm) and FE (1590mm)
- Saving: approx. 2.5 % engine cost
- Main parts affected: crankshaft, bedplate, column, crosshead, cylinder jacket
 - Additional spare parts on board: only one main bearing shell

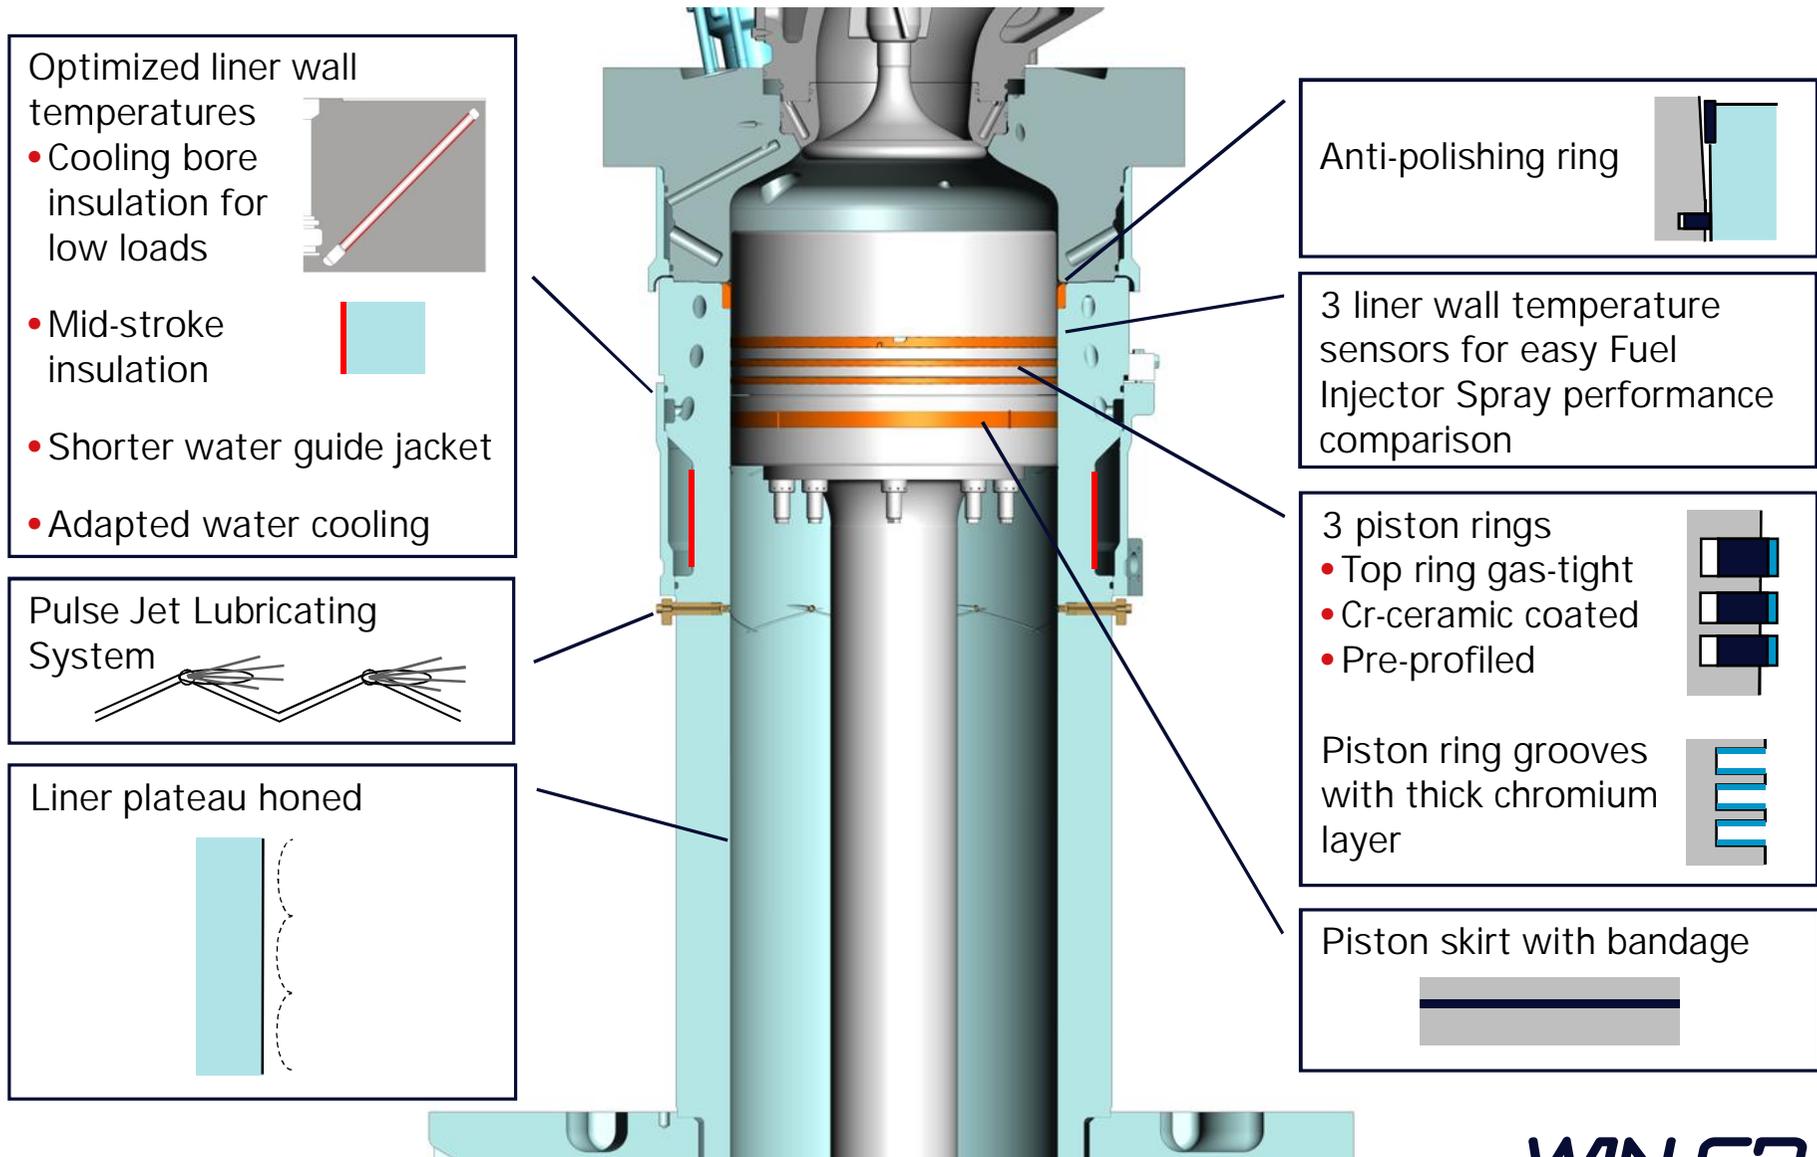
W-X92 – Piston Running Concept

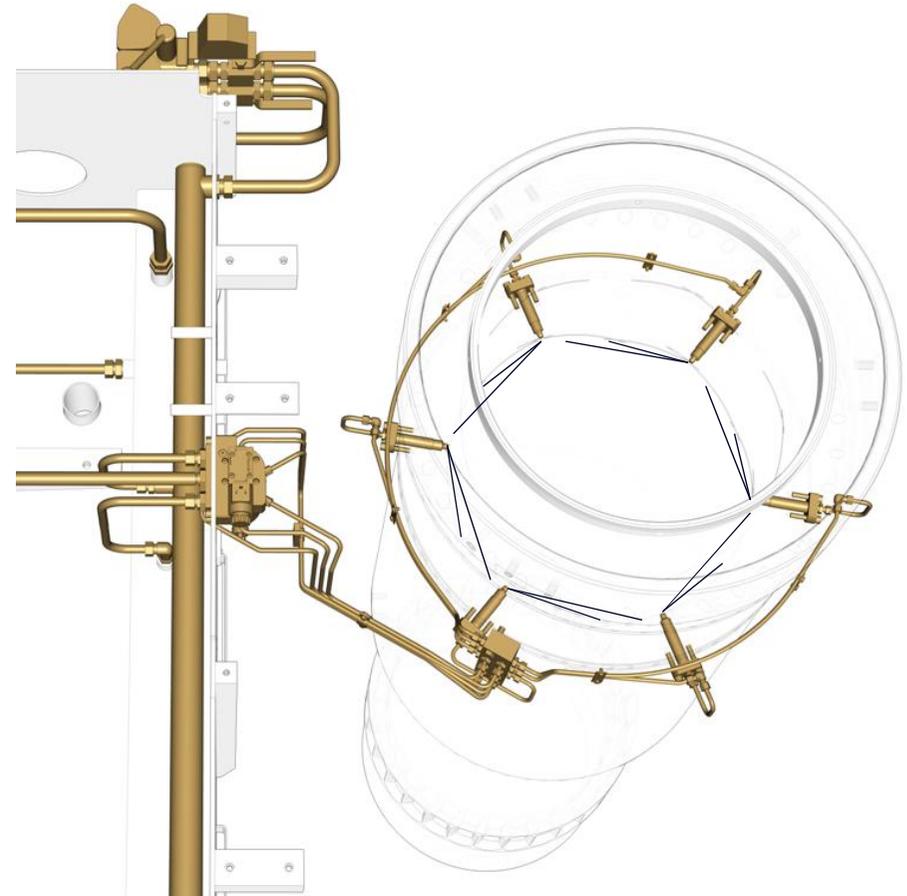
- *Cylinder lubricating system*
Pulse Jet Lubricating System
Flex lube pump
Lube oil distribution into, above and below piston ring pack
10 quills (simple non-return valves) for best radial distribution
Cylinder liner with oil grooves

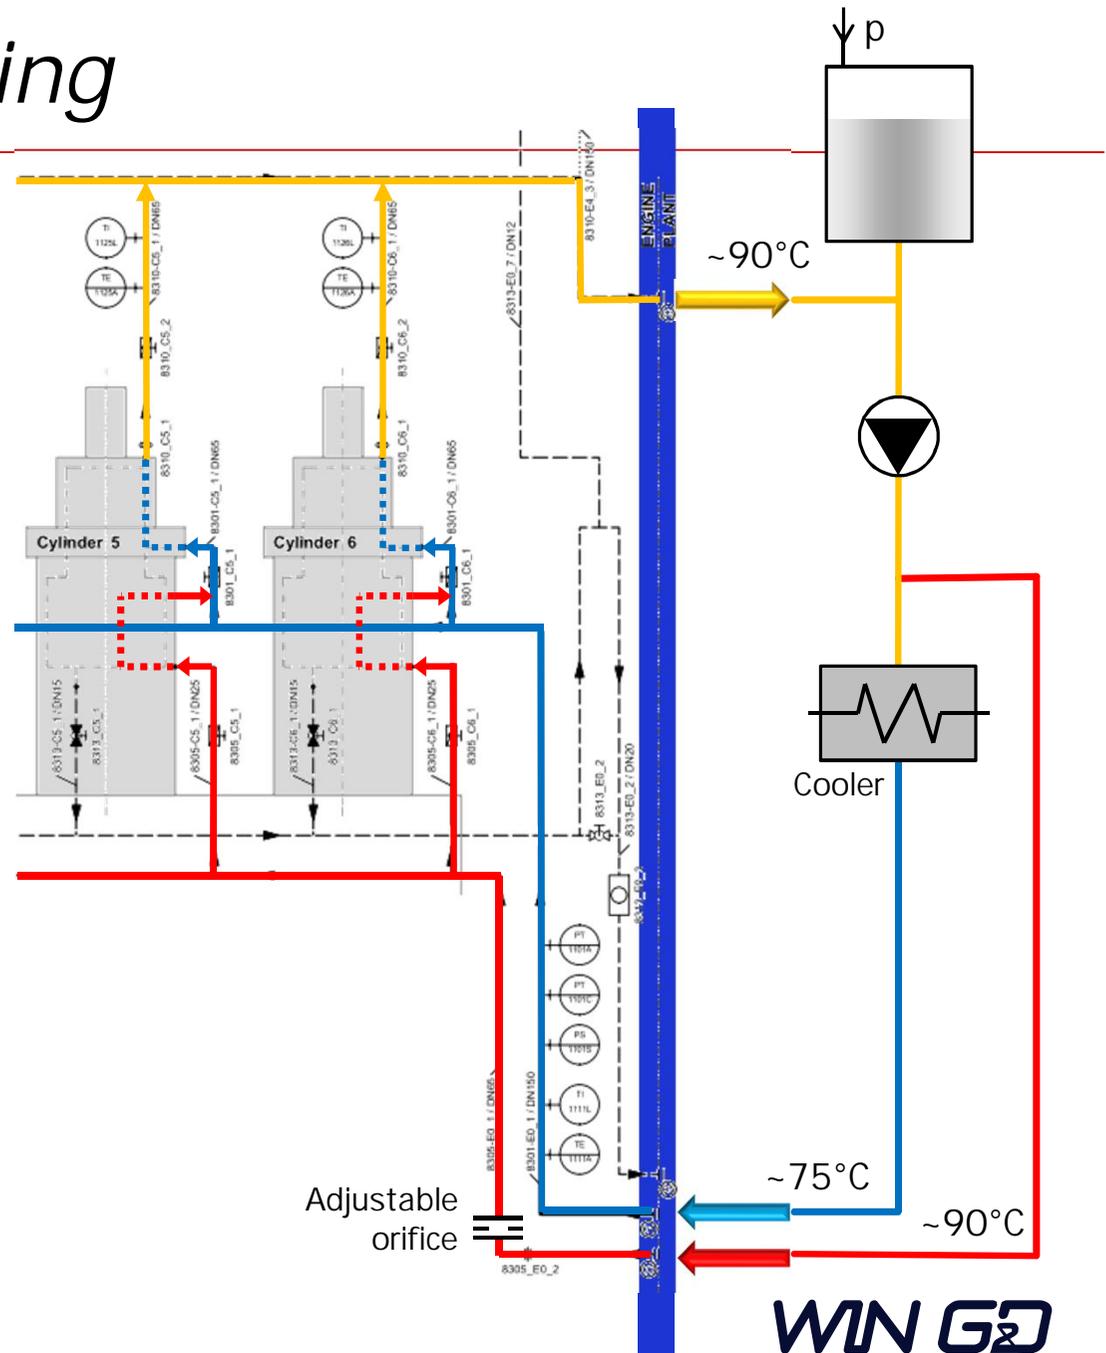
- *Cylinder liner cooling*
- *Bypass solution*
 - *Two yard connection*
 - *„Warm water“ for liner*
 - *„Cold water“ for cylinder cover and exhaust valve*
- *Pressurized cooling system*

Mid-stroke insulation
Insulation of cooling bores
(if necessary)

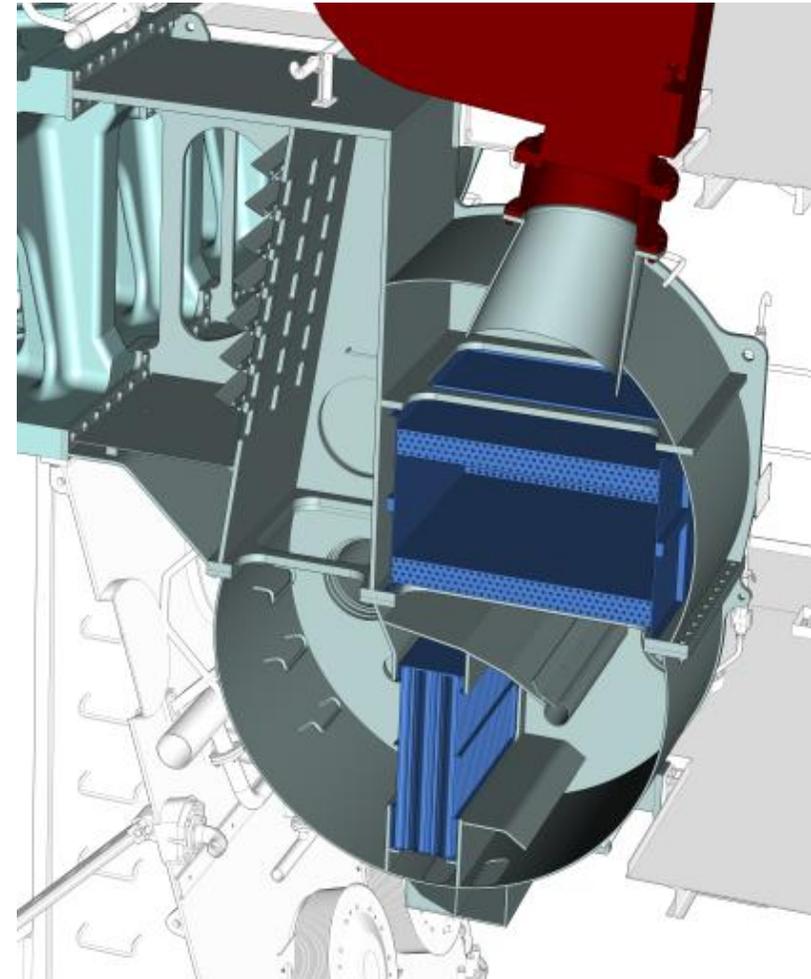
- *Water separation*
Underslung design for efficient natural water separation
 - *Air swirl supported water droplet separation*
 - *Radial acceleration of air flow leads to separation of > 80% of the water droplets*
 - *Additional water separator element for high efficiency*
 - *Effective drain (pressure balanced)*

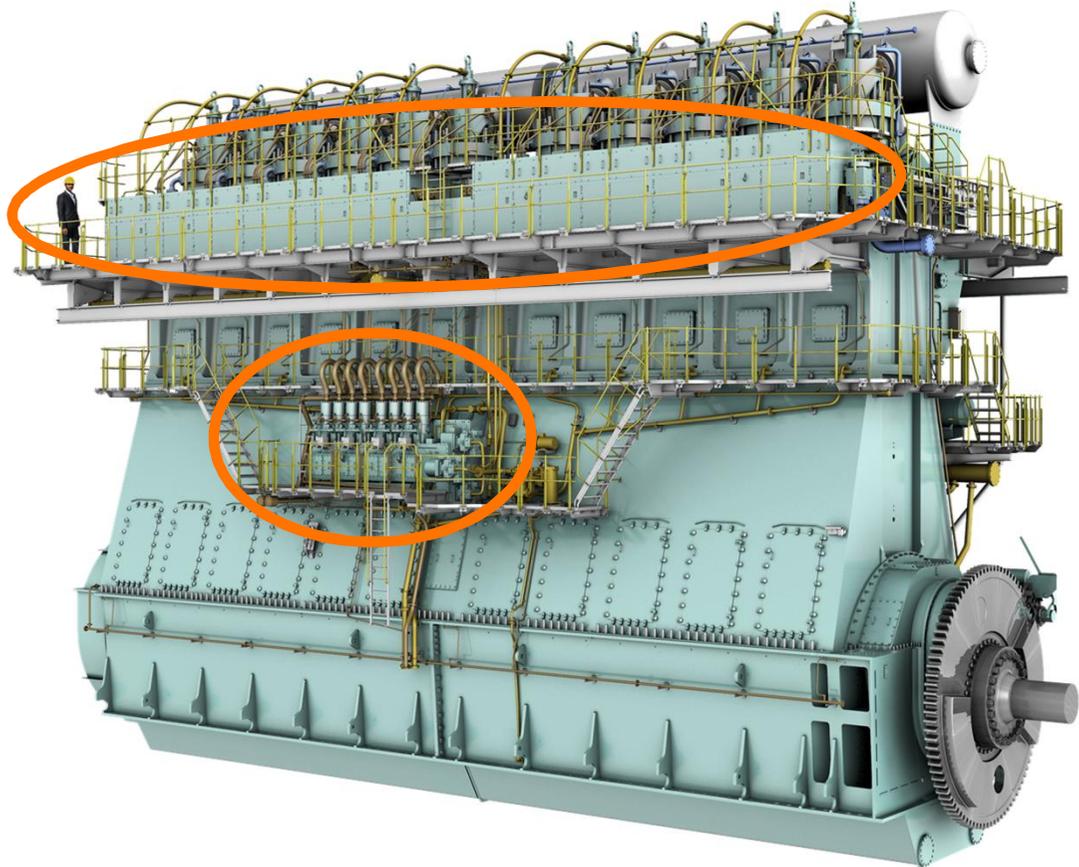
- *Flexsystem – overview*

Rail Unit

- *High pressure rails for fuel and servo oil*
- *Activation of exhaust valve and fuel injection by electronically controlled rail valves*

Supply Unit

- *Pressurizing of fuel and servo oil*

Redundant piping for fuel and servo oil between Supply Unit and Rail Unit

Redundant SOPs and FOPs

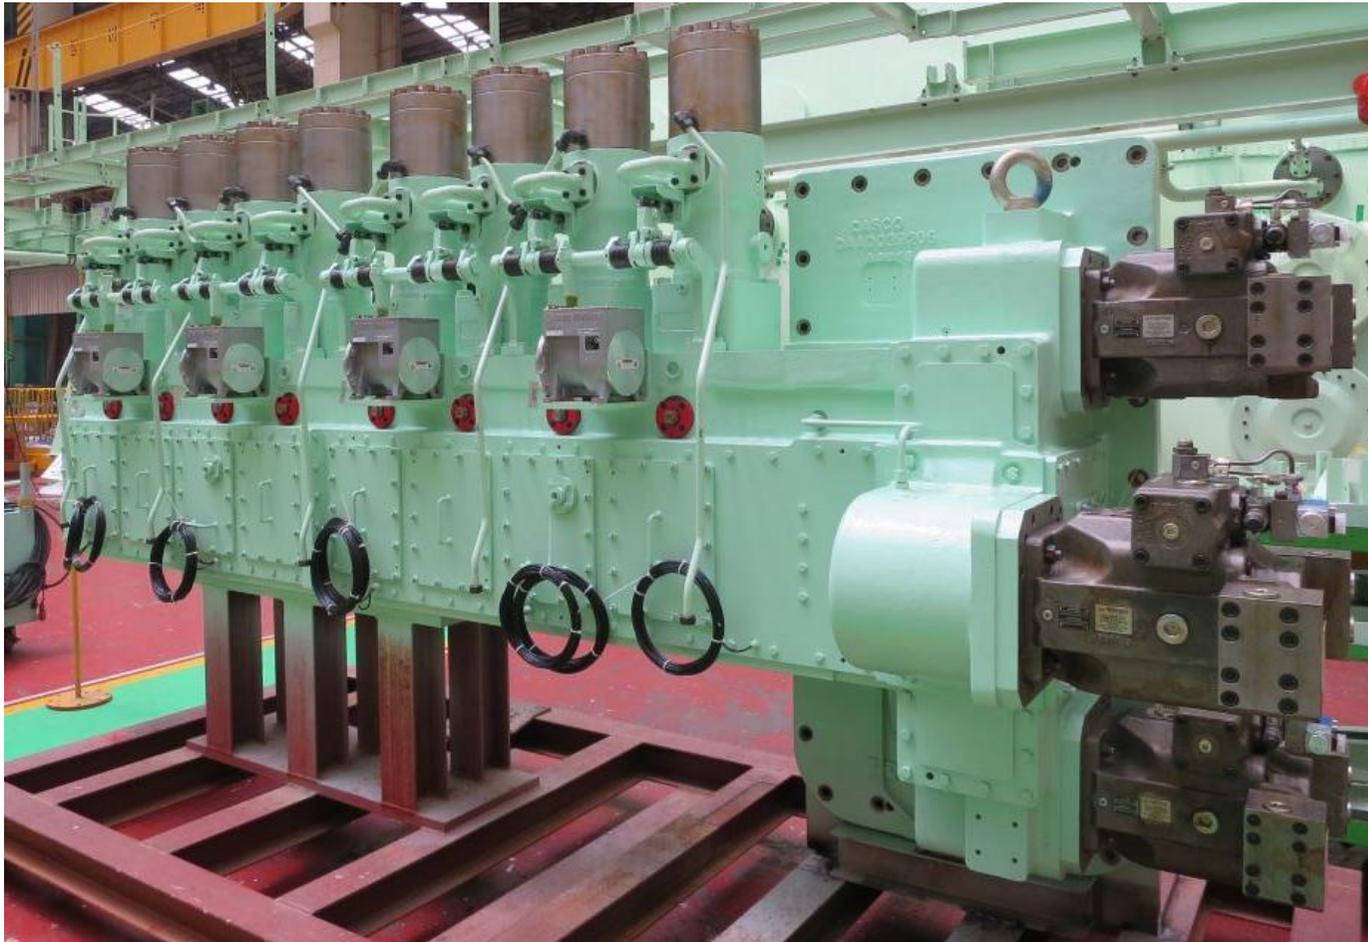
W-X92 – Supply unit with 8 fuel oil pumps and 3 servo oil pumps

- *Fuel and servo oil pumps*
Combined arrangement of heavy fuel oil and servo oil supply in one housing
Direct drive by the crankshaft wheel

W6X92	W7X92	W8X92	W9X92	W10X92	W11X92	W12X92
Number of FO pumps	4	6	6	6	8	8	8
	W6X92	W7X92	W8X92	W9X92	W10X92	W11X92	W12X92
Number of SO pumps	2	3	3	3	3	3	3

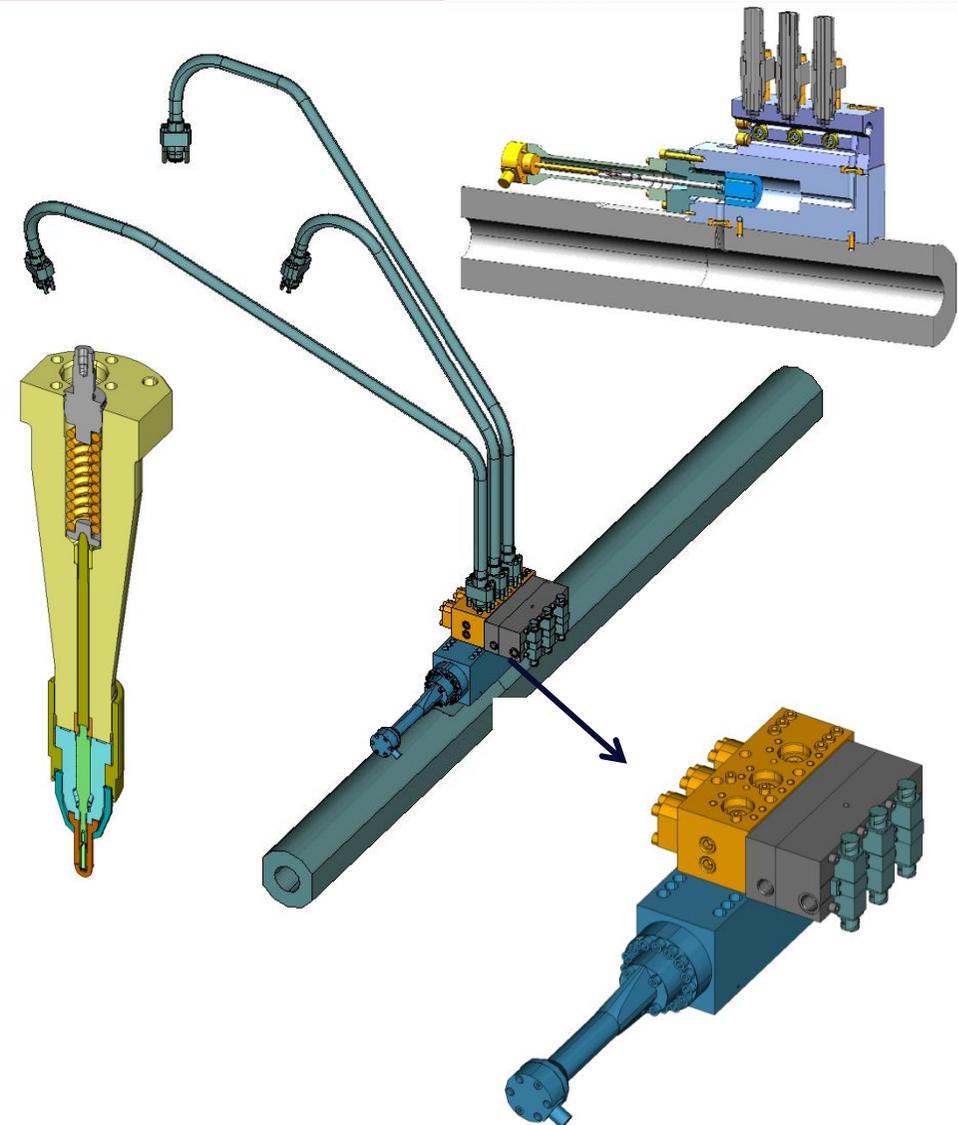
- *Fuel injection control*
Volumetrically controlled fuel injection with Injection Control Unit

- *Three rail valves per cylinder for optimized injection control at all engine loads*

Single wall rail pipe

FAST nozzle

(FAST = Fuel Actuated Sacless Technology)

- *Negligible sack hole volume*
- *Validated since 2010*
- *Clean combustion chamber*
- *Improved BSFC*

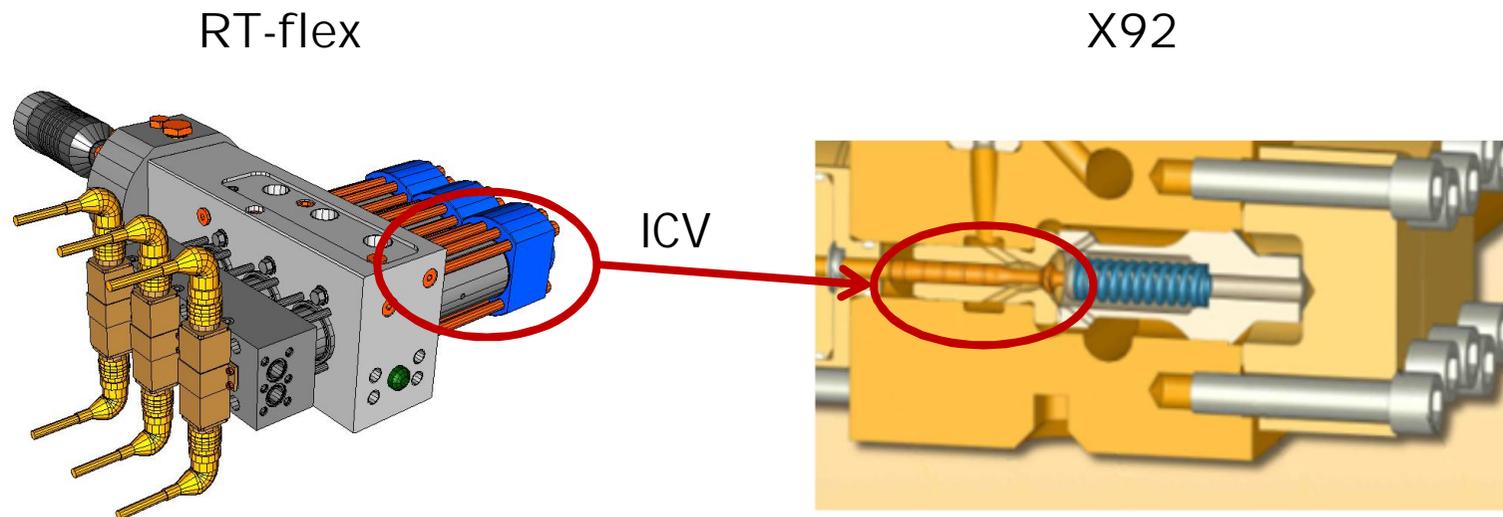
- *Fuel Injection Control Valves (ICV, a wear part) replaced by simpler inserts in the ICU block*
- *Reduced spare part costs*
- *Repair on board possible*
- *Improved maintenance friendliness*

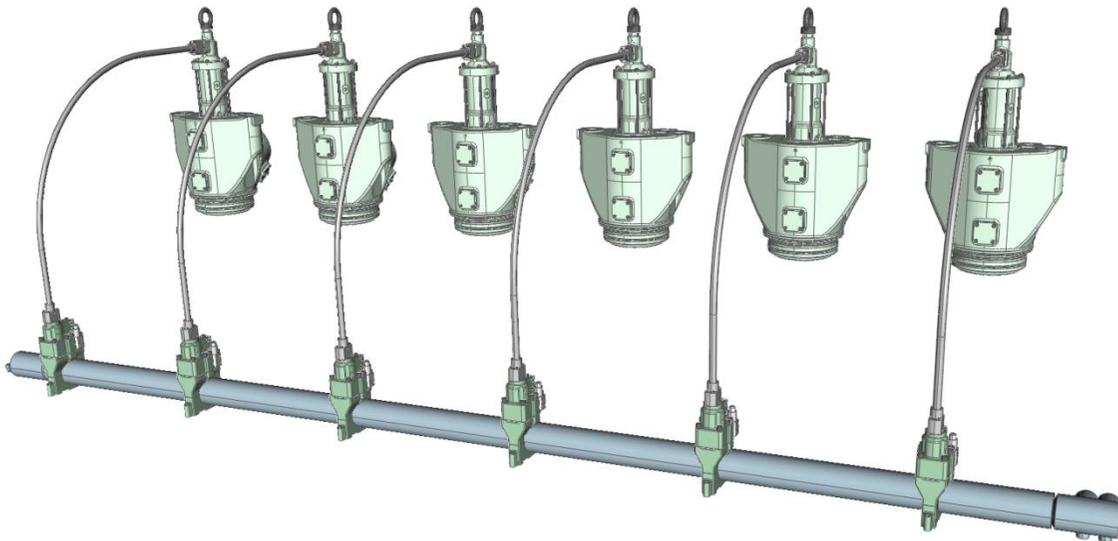
VCU – Exhaust Valve Control Unit

- *Electronically controlled exhaust valve movement*
- *Full flexible opening and closing*
- *Reliable servo oil rail single wall design*

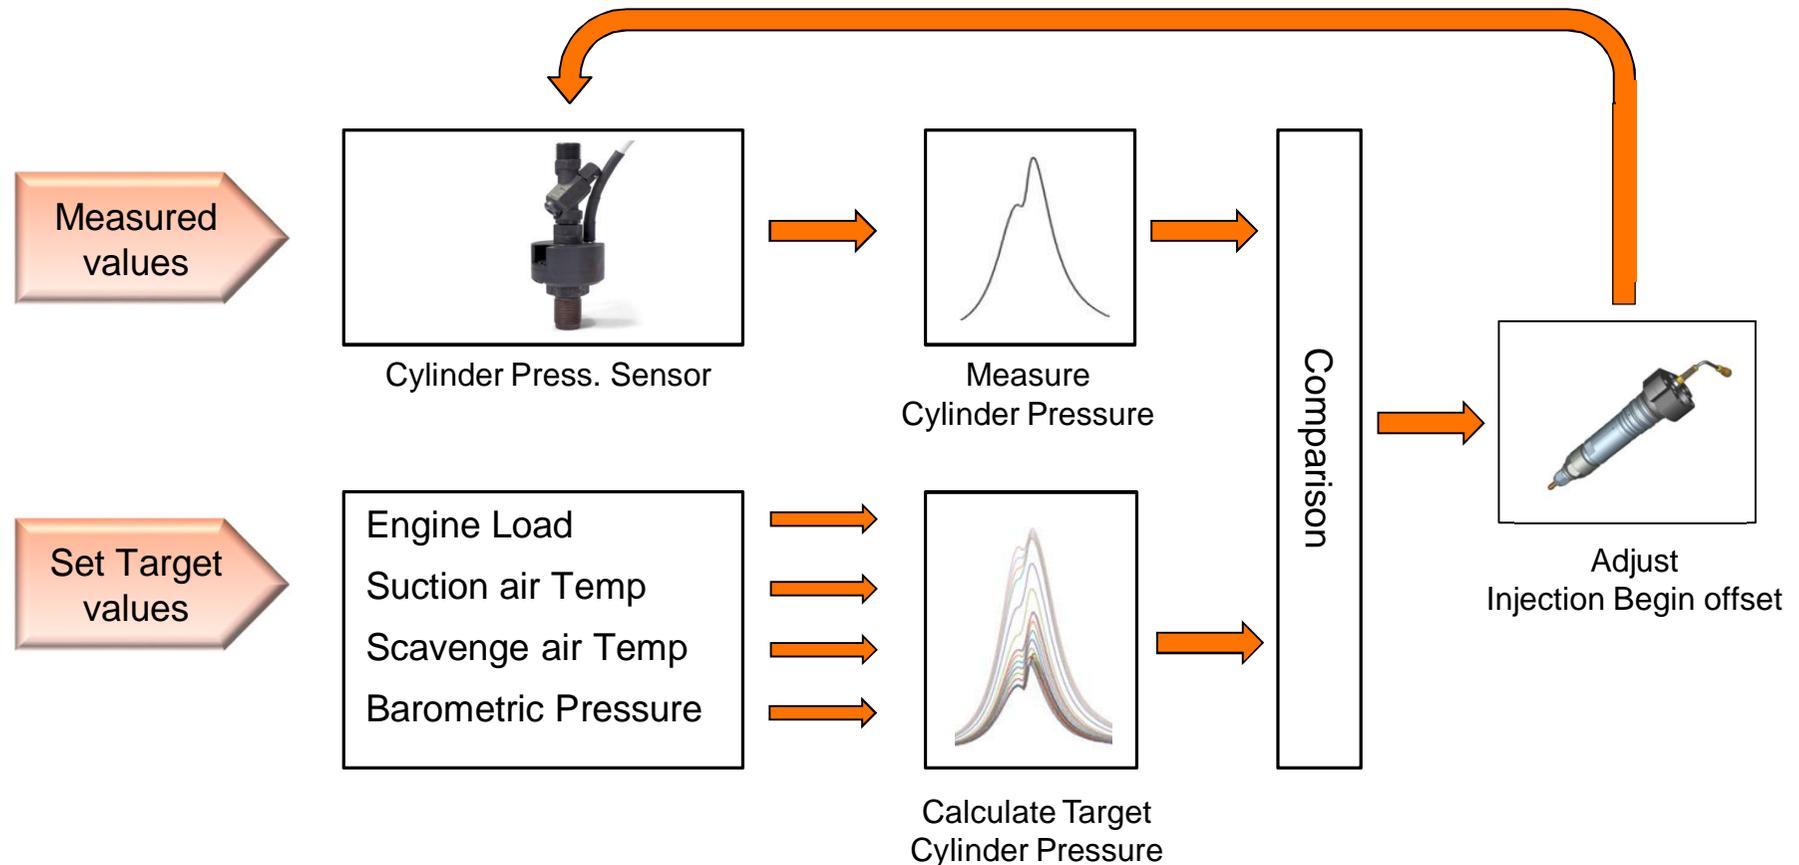
Automated cylinder pressure adjustment and control

- Up to 2.5 g/kWh fuel savings in service
- Continuous monitoring of compression and peak cylinder pressure

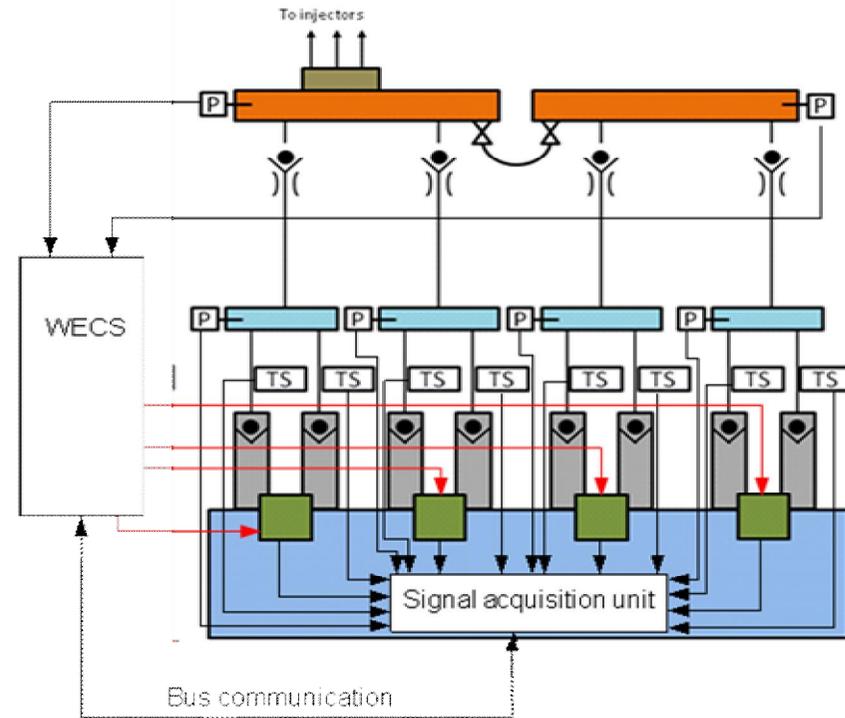
- *WECS 9520 system based on existing RT-flex engines*
- *Added features:*
 - Fuel Pressure Monitoring on fuel accumulators for leakage detection*
 - Cylinder Lubrication control adapted for Flex Lube pump*
 - Cylinder wall temperature monitoring as standard*
 - ICC as standard*

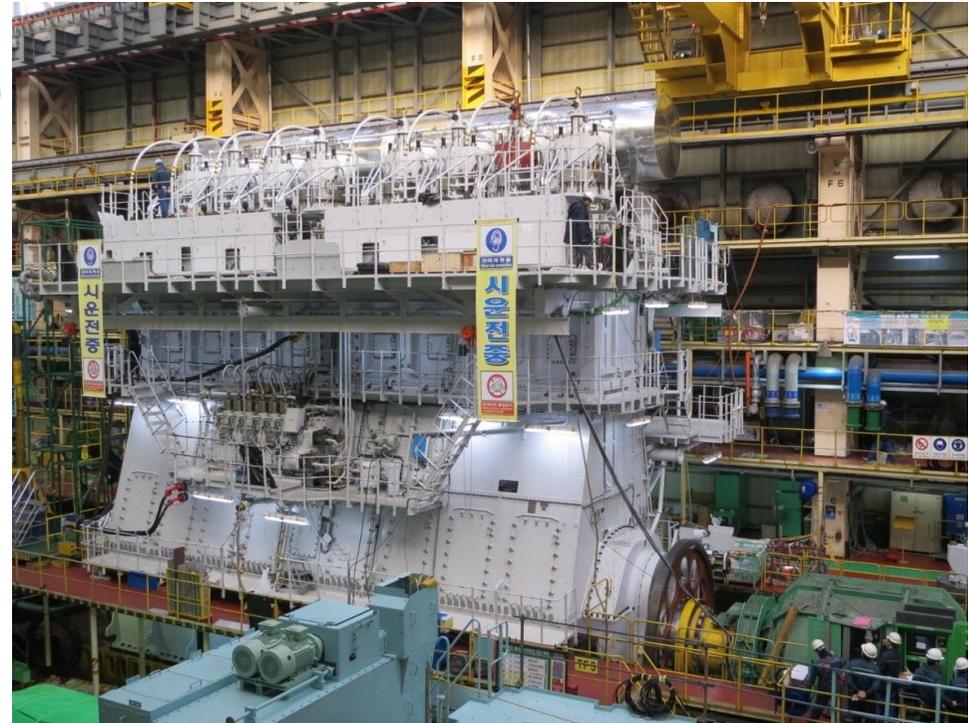
- *W-X92 engine testing*
W8X92 P0130 CINER prototype testing
 - *Power* *38590kW (78.7% R1+)*
 - *Speed* *74 rpm (92.5% R1+)*
 - *Tuning* *Delta Bypass*

Successful FAT on 17.02.15 at HHI-EMD

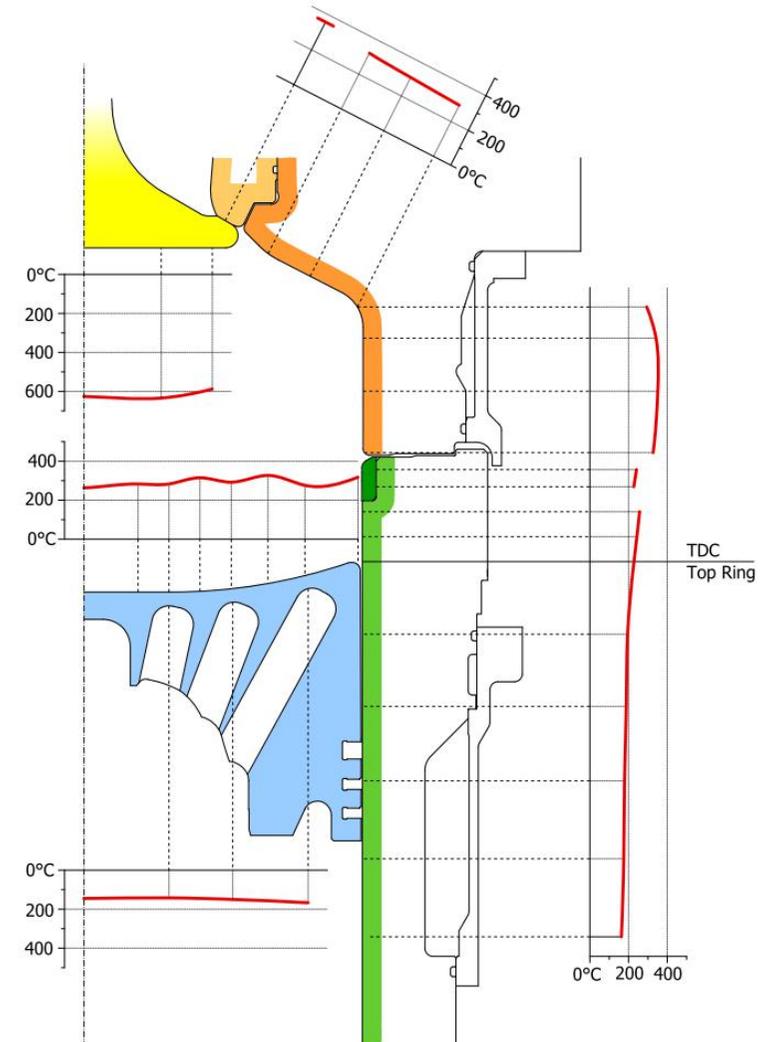
- Extensive prototype testing, measurements:
Temperature measurements

- Piston
- Cylinder liner & cover
- Exhaust valve

Stress measurements

Vibration measurements

- All measured values within permissible limits
