Winterthur Gas & Diesel

W-X92

The most efficient Engine for large Container Vessels

W-X92, June 2016 / H. Brunner, J.-N. Constantin, L. Knipstrom

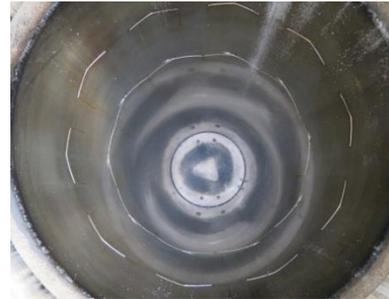
Cylinder liner

- *Component inspection*
All relevant components checked during testing and after Factory Acceptance Test
- *All components in good condition*

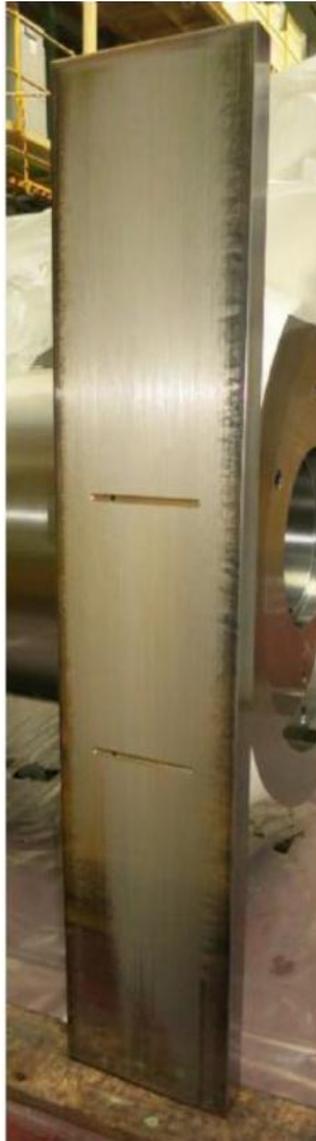
*W8X92 – Guide shoe
Inspection after shop test*

- *Running marks on both edges*
- *Improvement introduced
Oil groove enlarged
Better oil distribution*

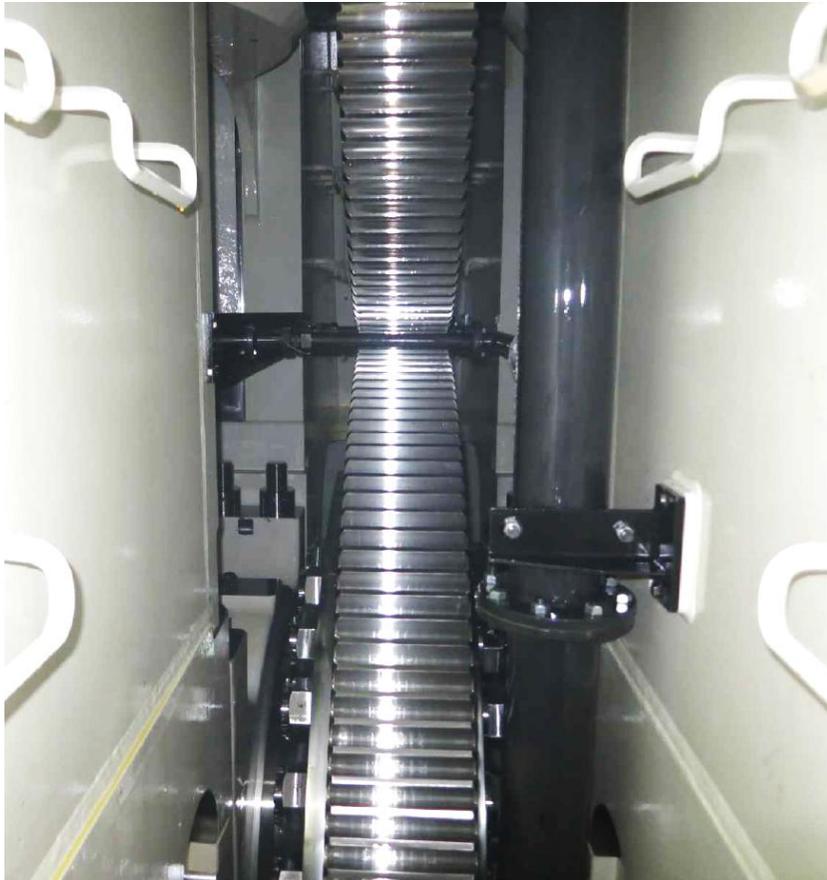
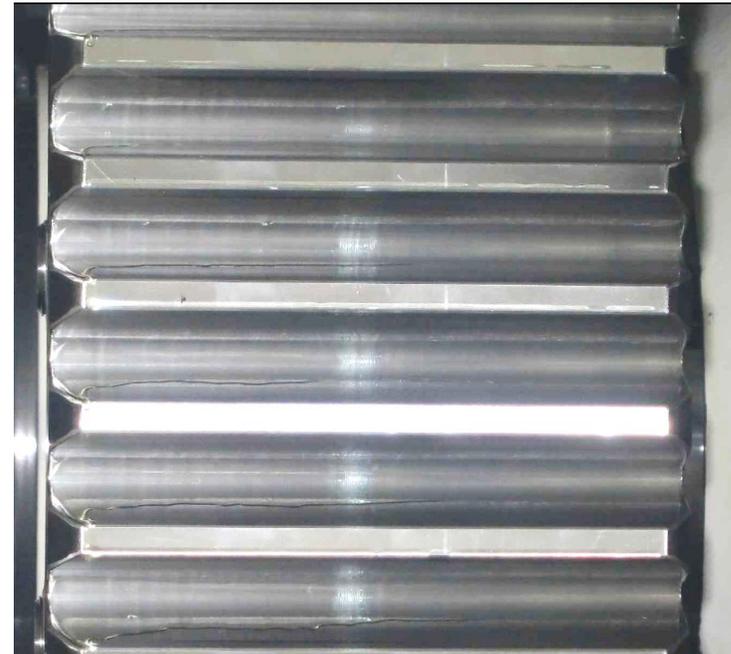
Inspection at 153 rhs

- Gear wheels in outstanding condition
- Clean crankcase space

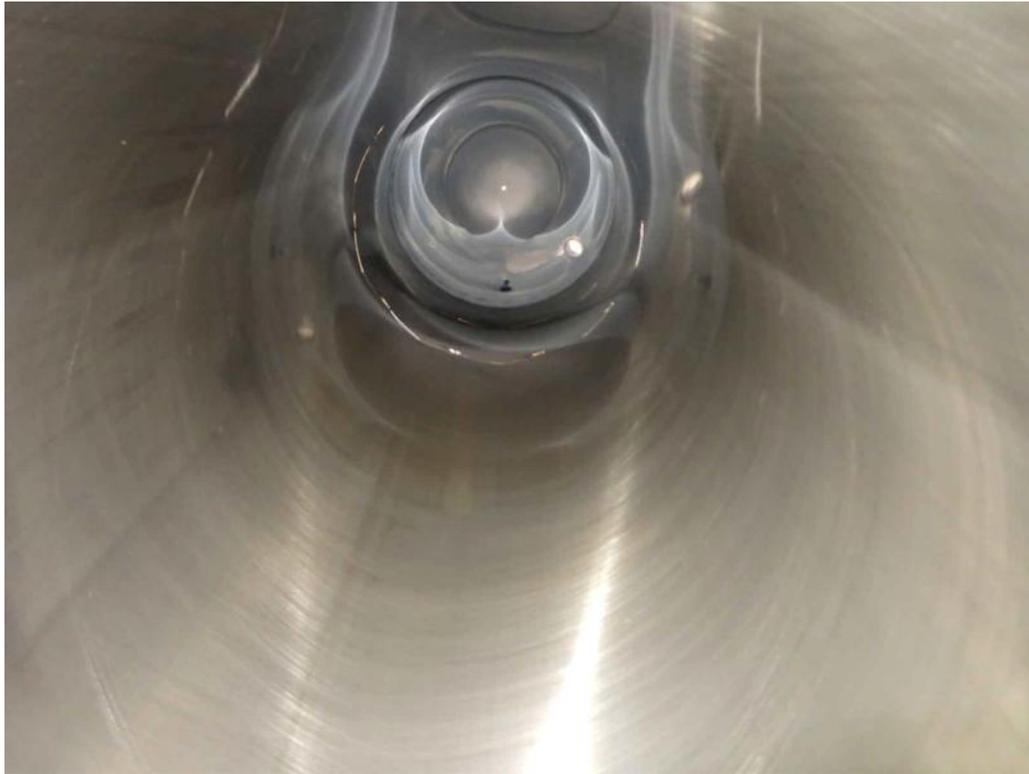
Inspection at 153 rhs

- *All units in good condition*
- *Oil in use: BN100*
- *2.87 % sulphur*
- *Feed rate: 1.0 g/kWh*
- *Residual BN: 60 – 70*

➔ Feed rate can be further reduced

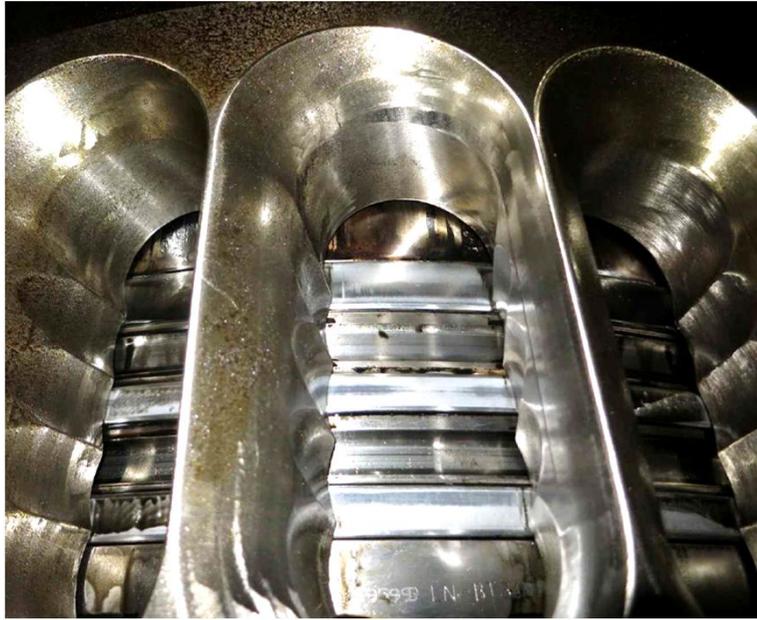
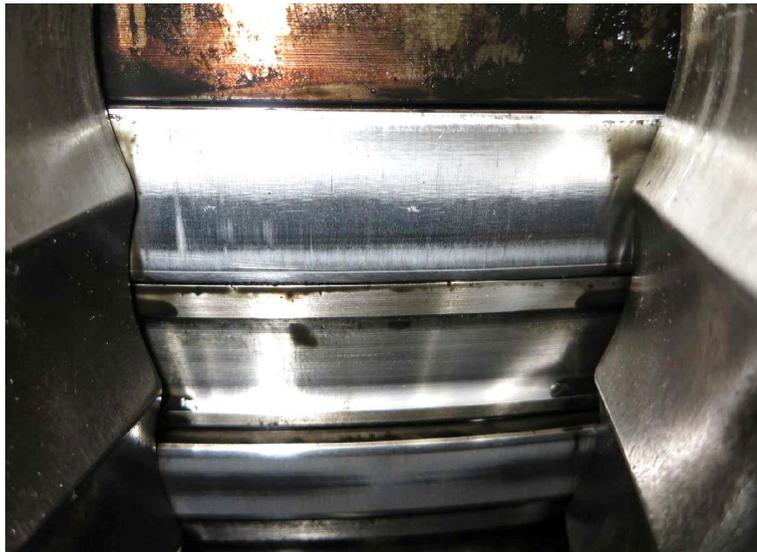
W8X92
Inspection at 153 rhs

- Piston ring in good condition
- Clean piston ring pack
- Moderate deposits on piston head
- Top piston ring with good contact area

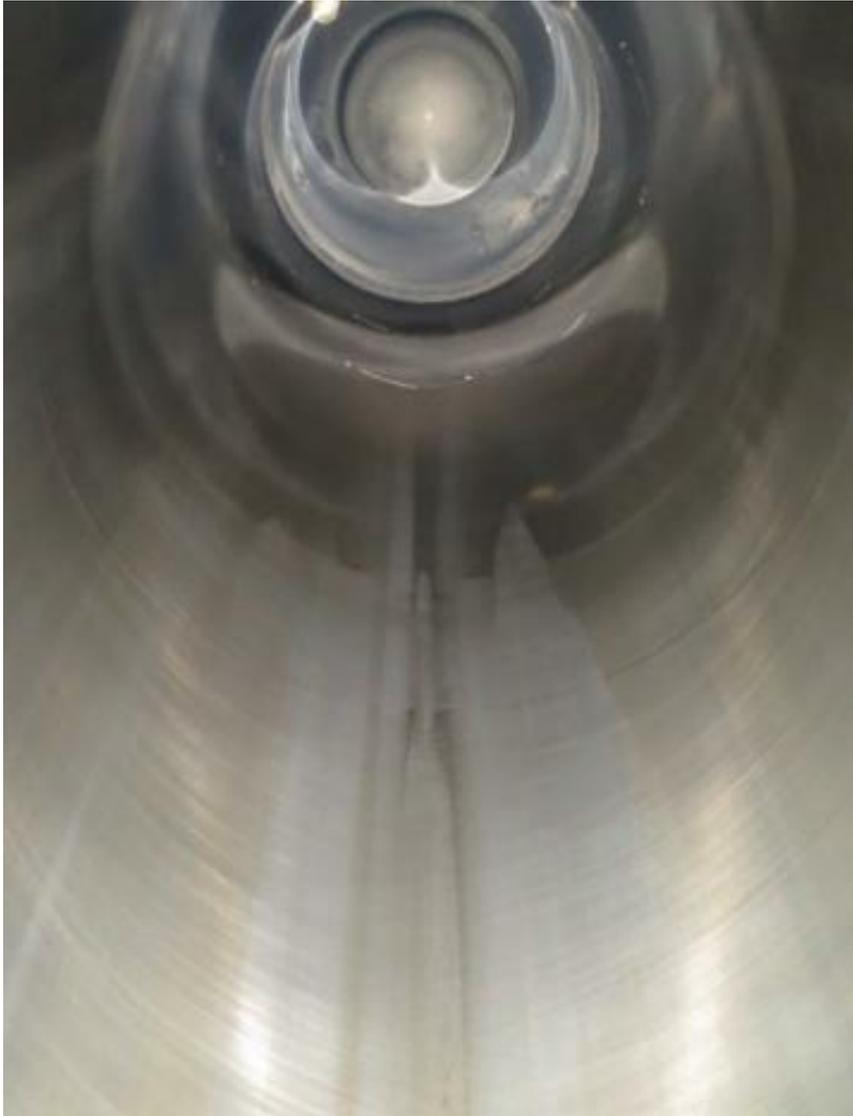
Inspection at 789 rhs

- *All units in good condition*
- *Oil in use: BN100*
- *3.21 % sulphur*
- *Feed rate: 1.0 g/kWh*

➔ Feed rate can be further reduced

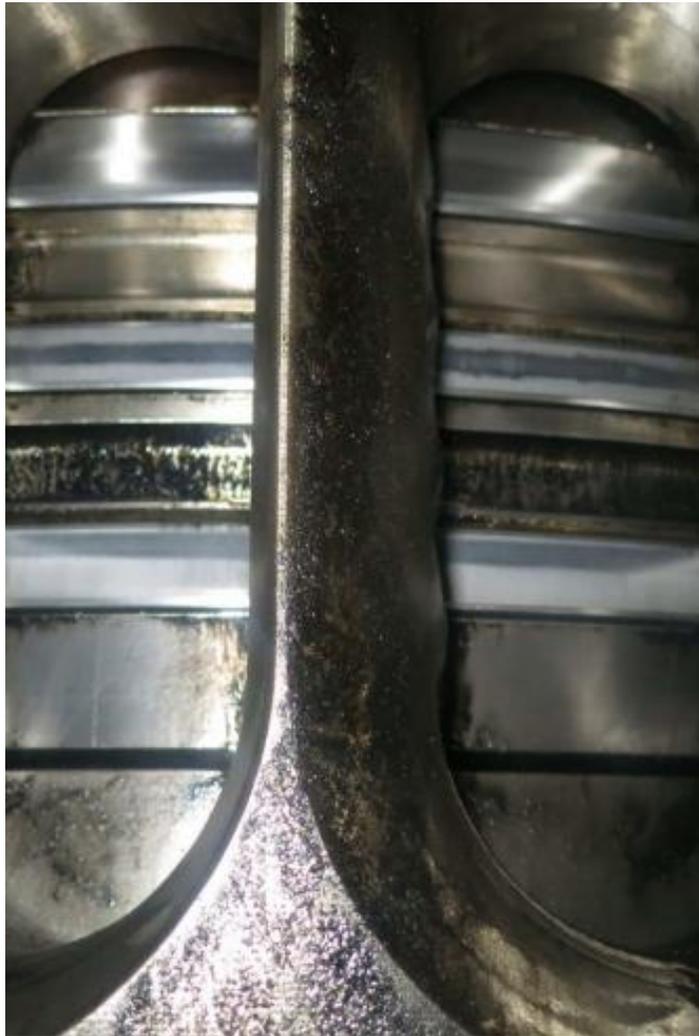
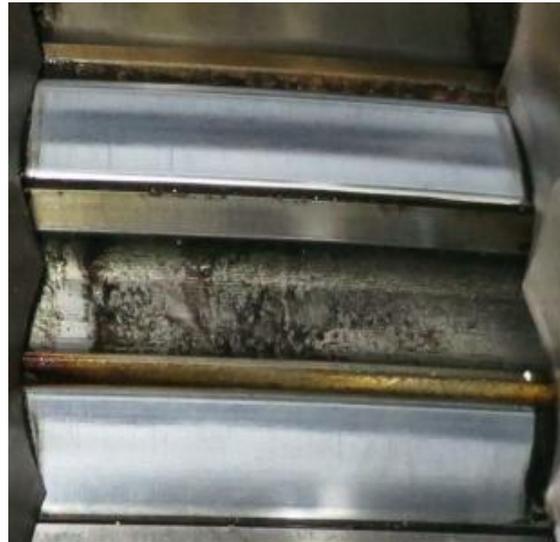
W8X92
Inspection at 789 rhs

- *Piston ring in good condition*
- *Clean piston ring pack*
- *Moderate deposits on piston head*

- *Top piston ring with good contact area*

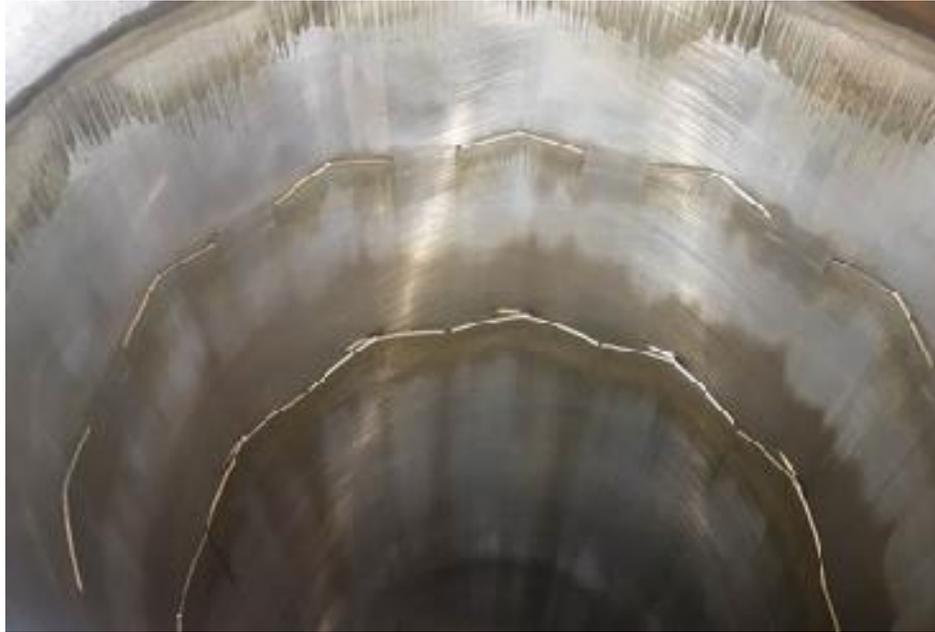
W-X92 Service Experience – Piston Running

- *Cylinder liner not cleaned*
- *Honing marks still visible on the whole stroke*
- *Residual BN from piston underside drain is too high*

➔ *Feed rate should be further reduced*

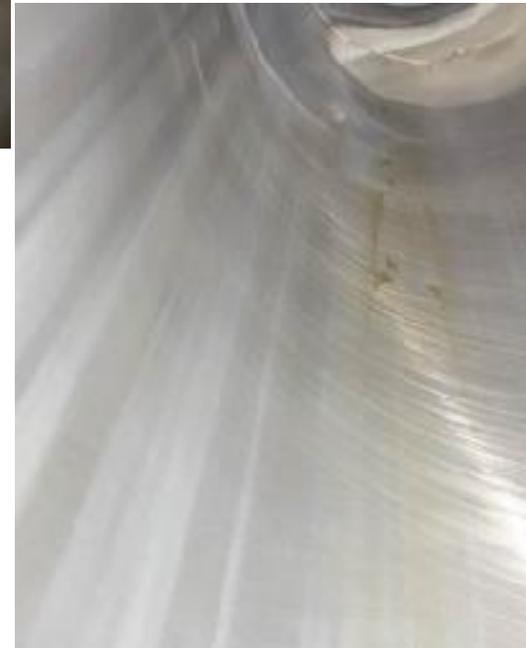
Inspection at 4'030 rhs

- *All units in good condition*
- *Oil in use: BN100*
- *Engine load 40-60%*
- *2.75 % sulphur*
- *Feed rate: 0.9 g/kWh*

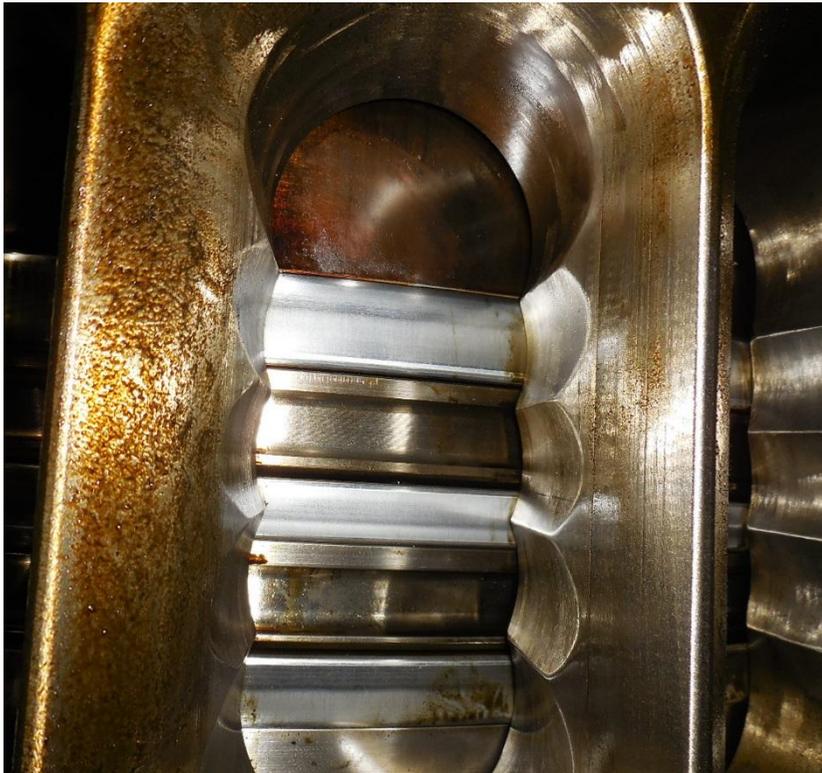
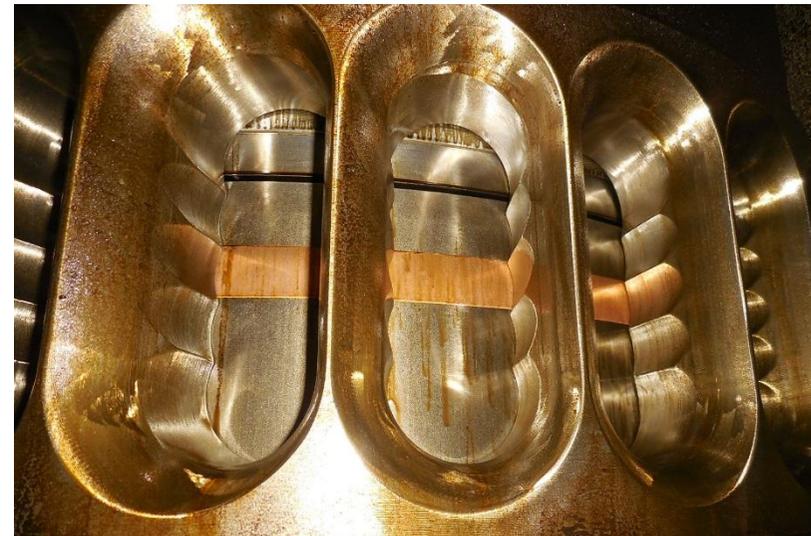
Inspection at 4'030 rhs

- Piston ring in good condition
- Clean piston ring pack
- Moderate deposits on piston head
- Top piston ring with good contact area

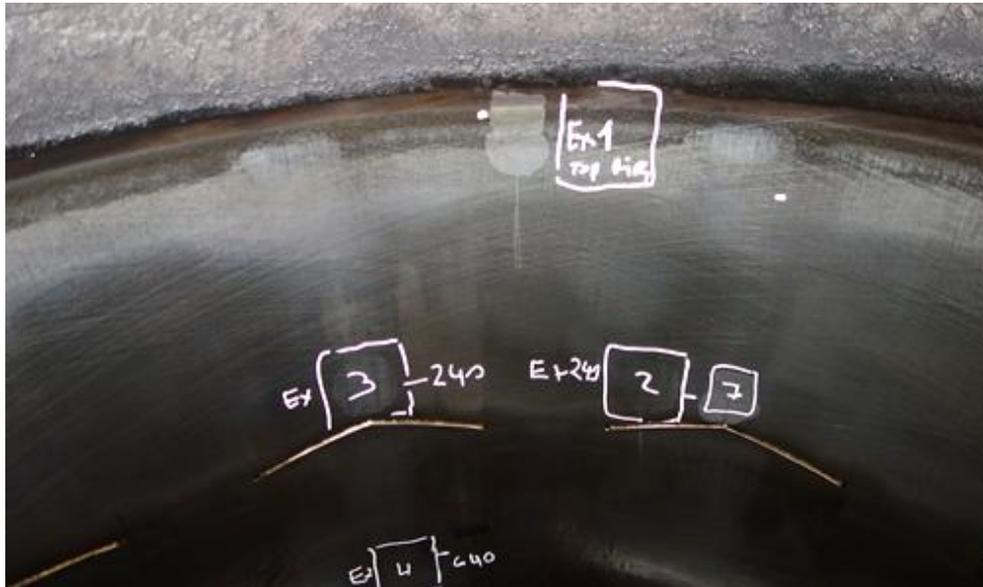
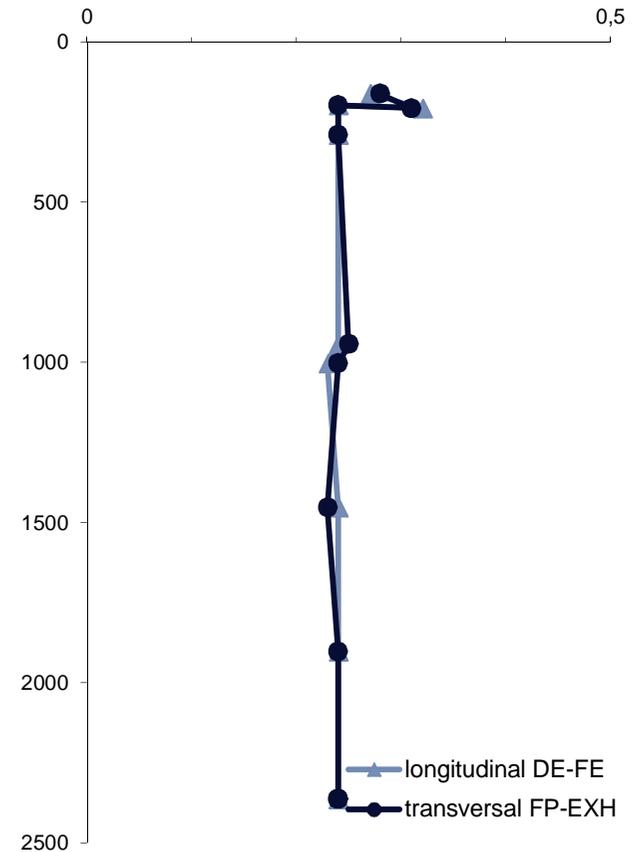
Liner wear profile

- Nearly no wear
- Measured wear rate: 0.01 mm/1000h

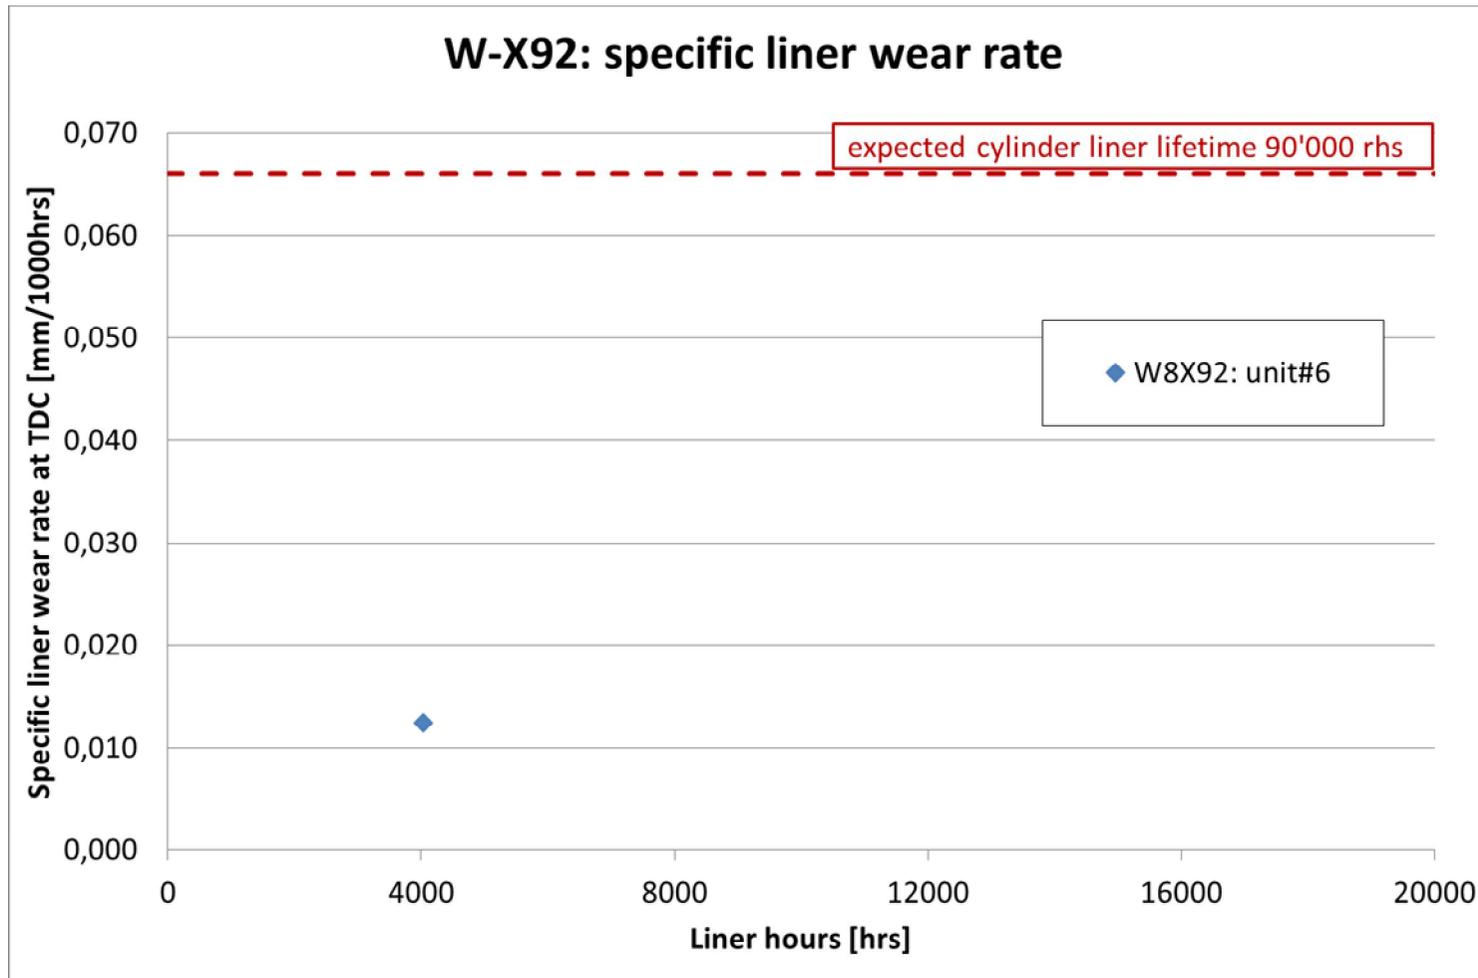
X92 piston running concept with excellent specific liner wear rate

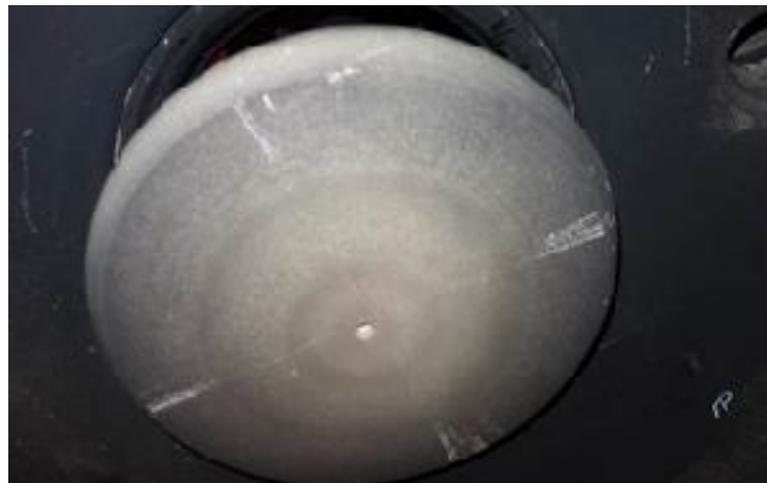
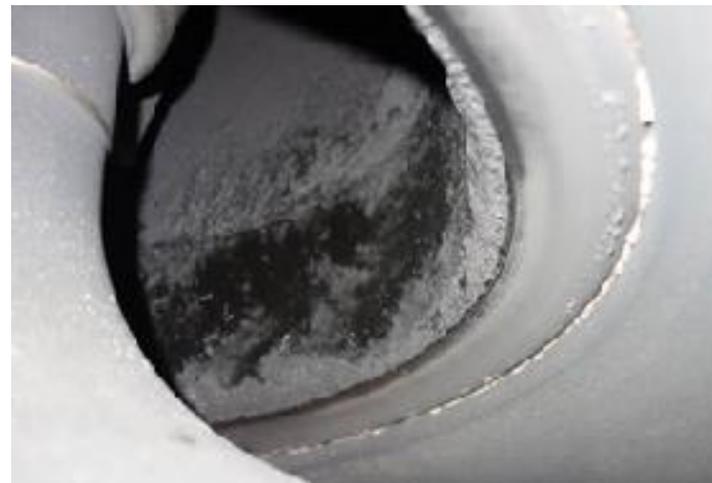
Inspection at 4'030 rhs

- *Injector nozzle tips*
 - *Exhaust valve*
 - *Exhaust valve seat*
- ✓ *Good condition*

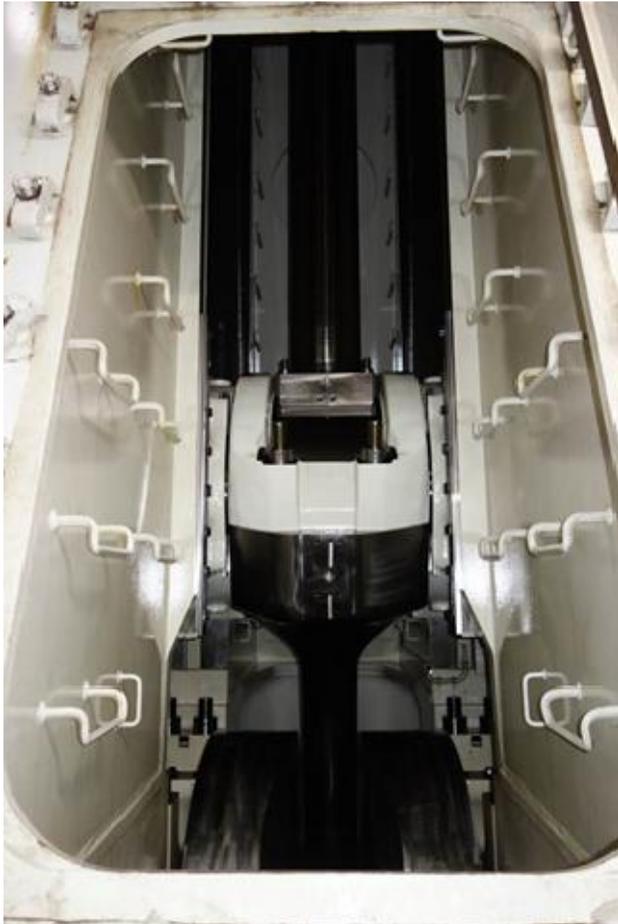
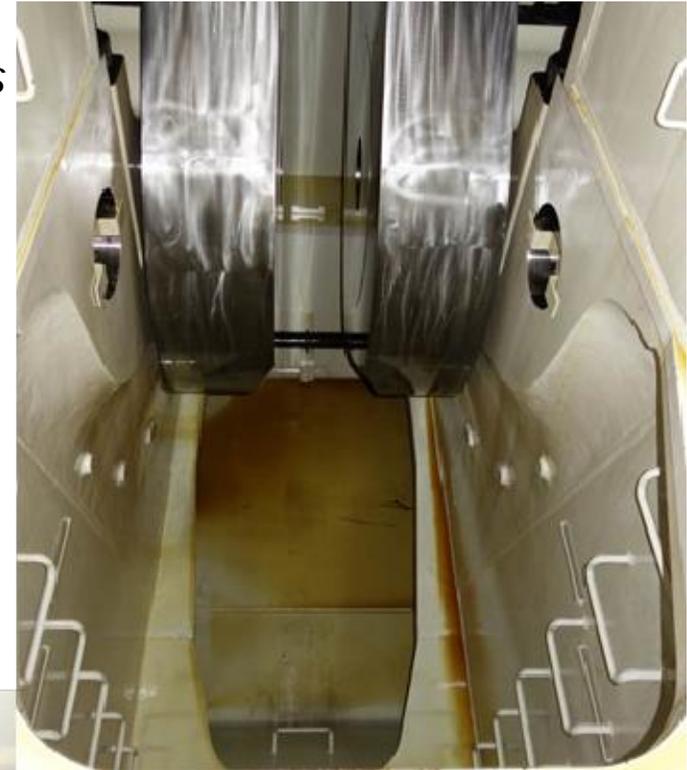
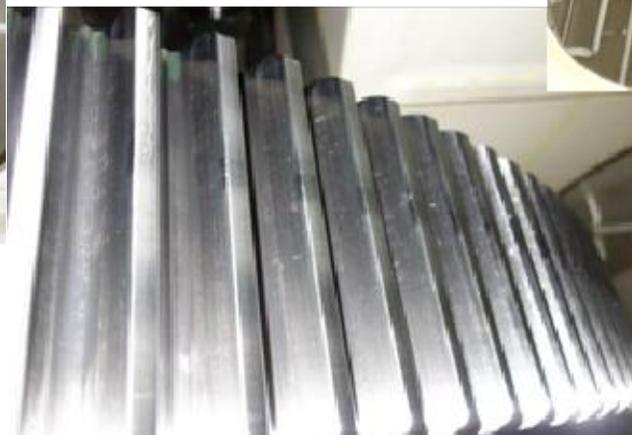
W8X92
Inspection at 4'030 rhs

- Clean crankcase
- No abnormality
- ✓ Good condition

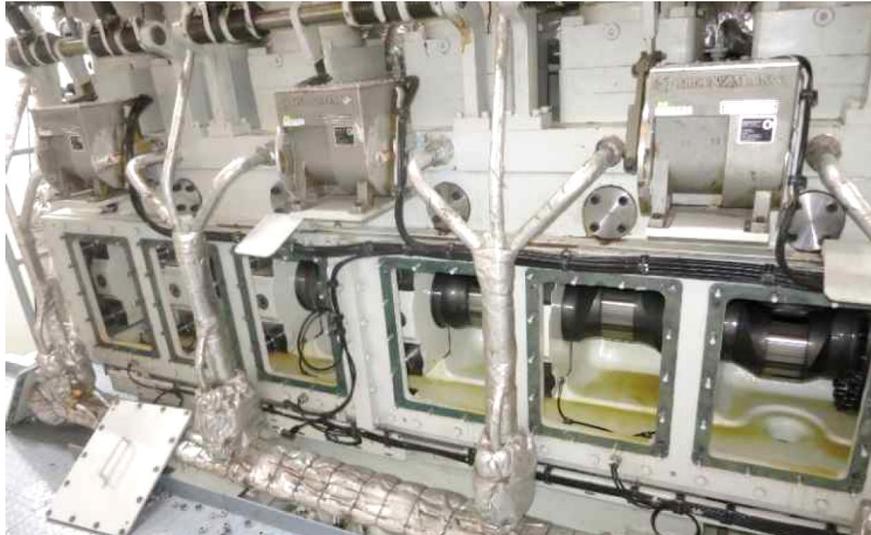
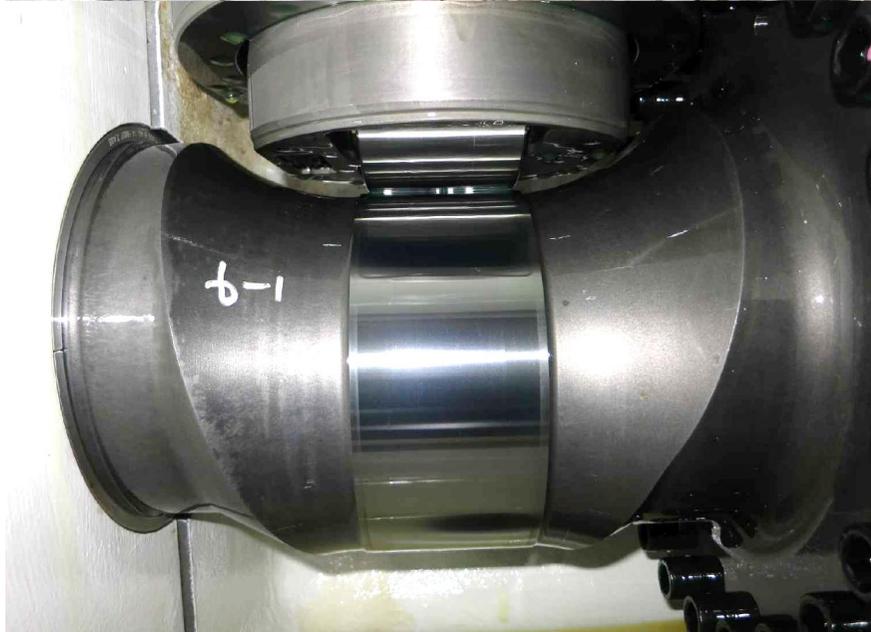
*W8X92 – Supply unit
Inspection at 789 rhs*

- *Camshaft in good condition*
- *All fuel oil pump rollers visually inspected and in excellent condition*

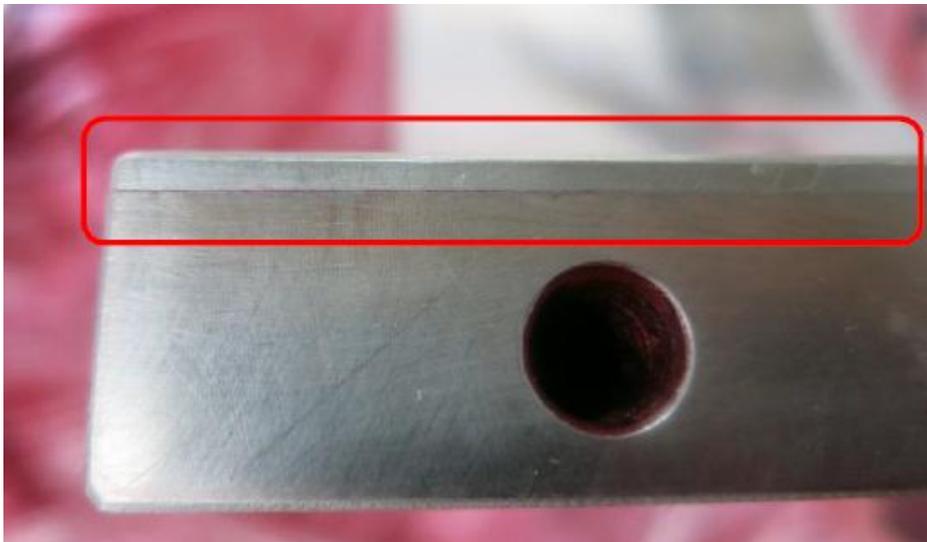
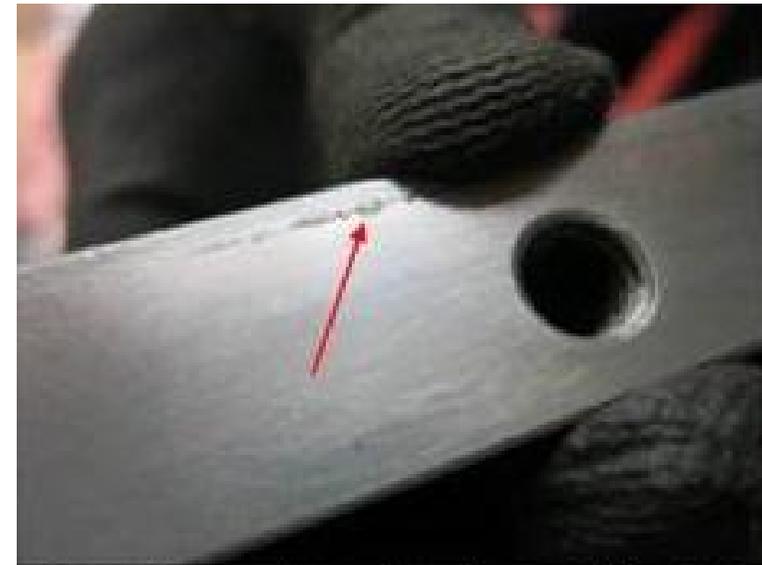
- *Some main bearing shells of first engine showed no bonding after shop test*
 - *Gap existing between steel back and white metal*
- *Root cause analysis was thoroughly done*
 - *Design*
 - *Manufacturing quality*
 - *Dimensions*
 - *Assembly*

Some oil was coming out from the gap(de-bonding)

- Surrounding temperature very cold
not possible to keep stable temperature during manufacturing
- Welding influence on bonding/material properties

- Temperature control
- Welding preparation changed from V-shape to smaller K-joint

- *Root cause analysis done*
 - *Manufacturing quality deficiencies found*
 - *Improvements introduced*
 - *Quality improvement validated by material expert audit*
 - *Test pieces produced and checked*

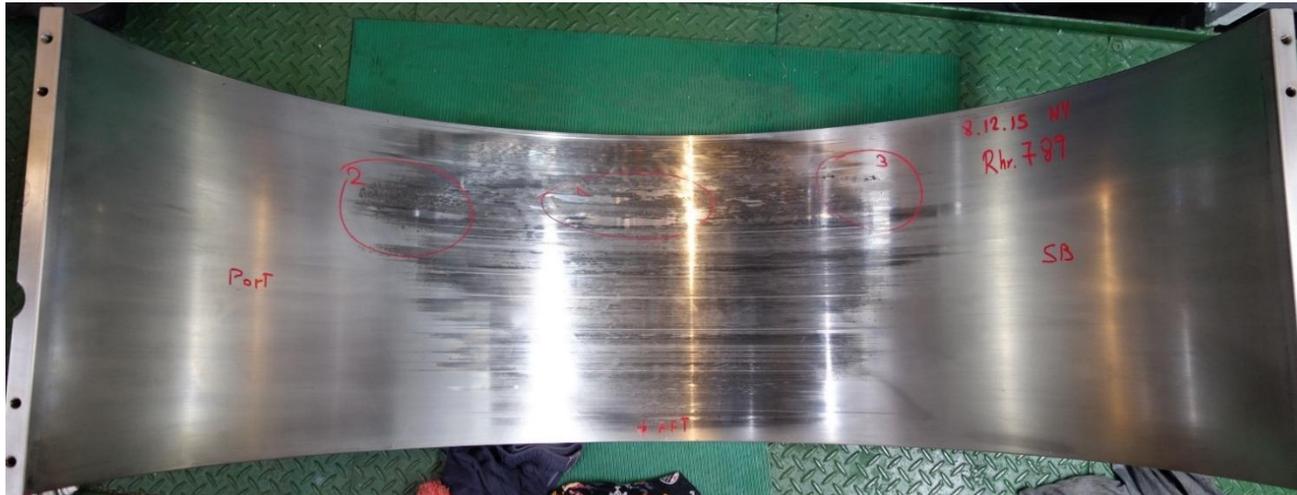
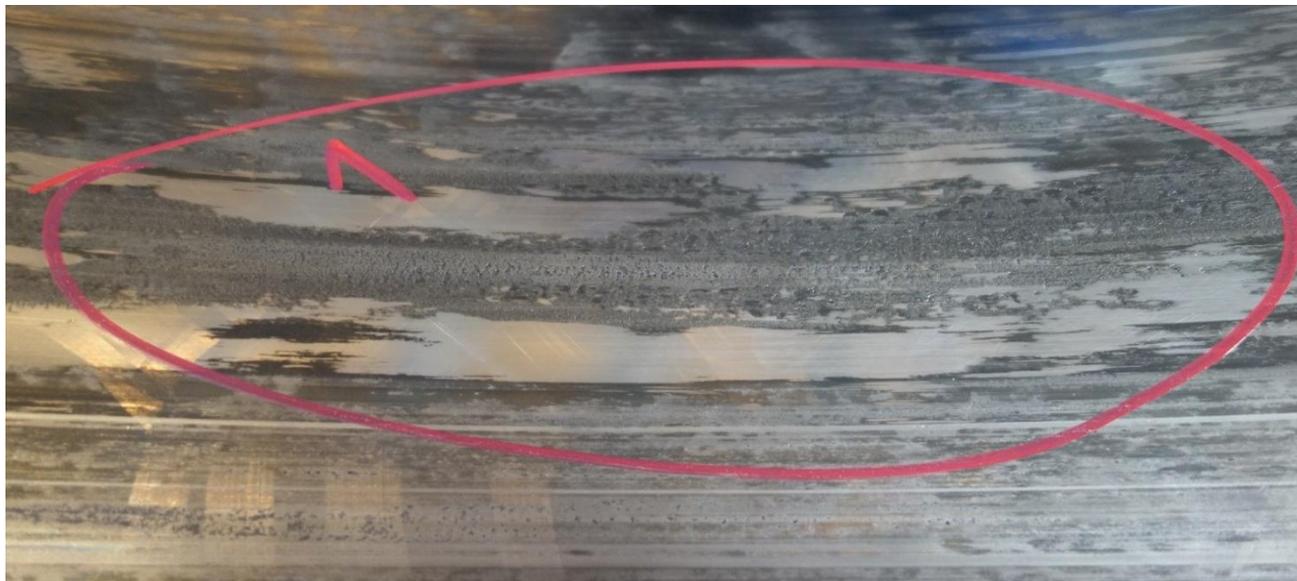
MB#2 at 789h

- Pulled out material
- Probably due to dry turning during assembly
- Shell exchanged
- Main journal in good condition

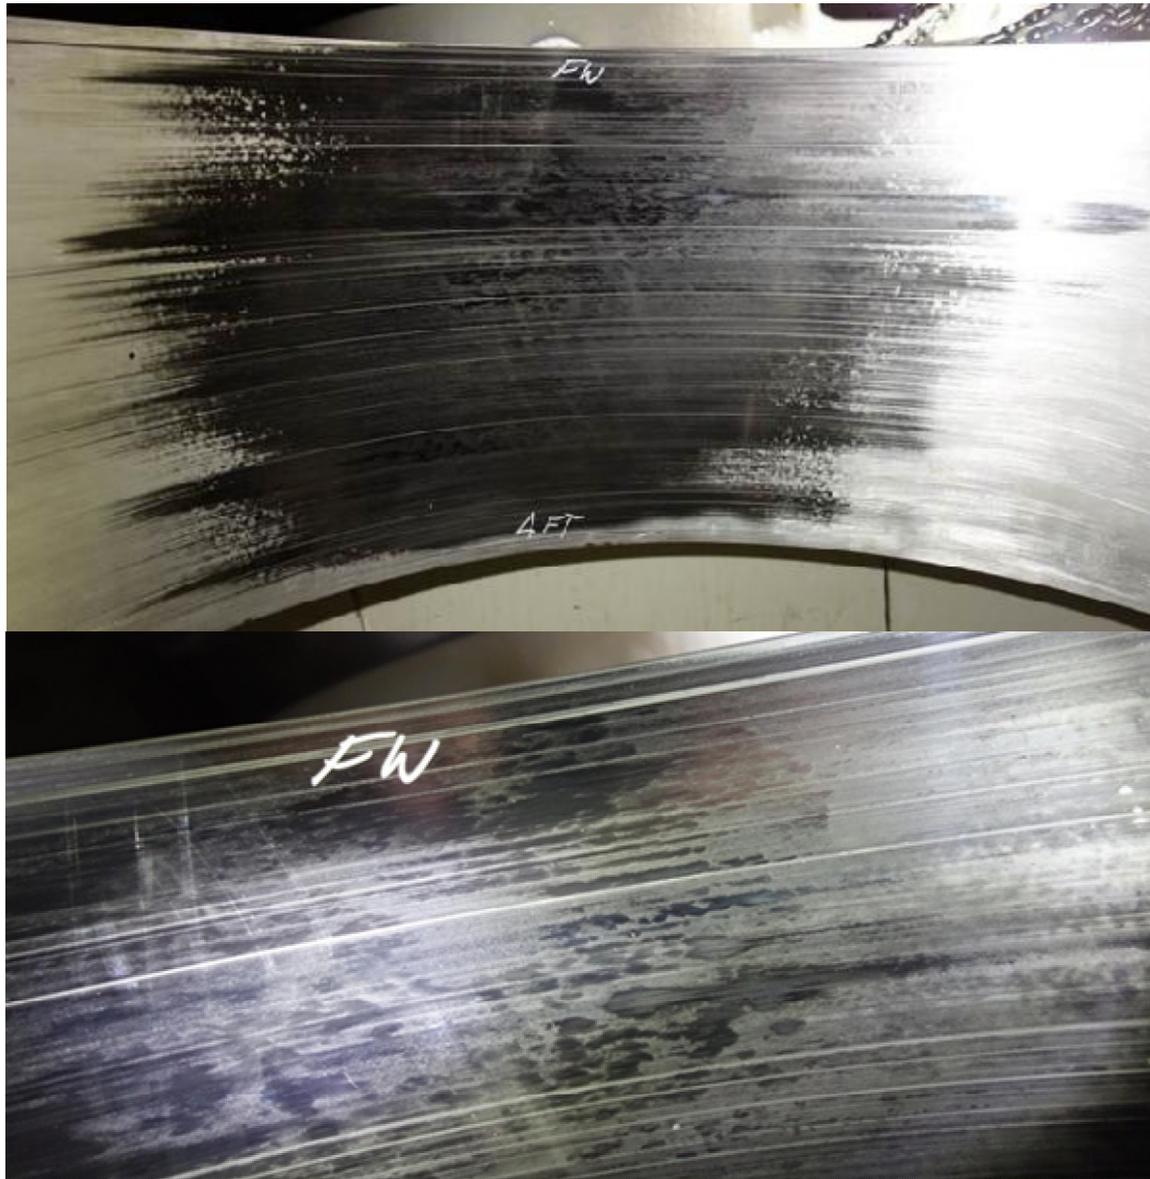
*MB#2 at 4000 h
Shell at 3'200 h*

- *Running marks evenly distributed*
- *No pulled out material*
- *Confirmation of good running behaviour*
- *Main journal in good condition*

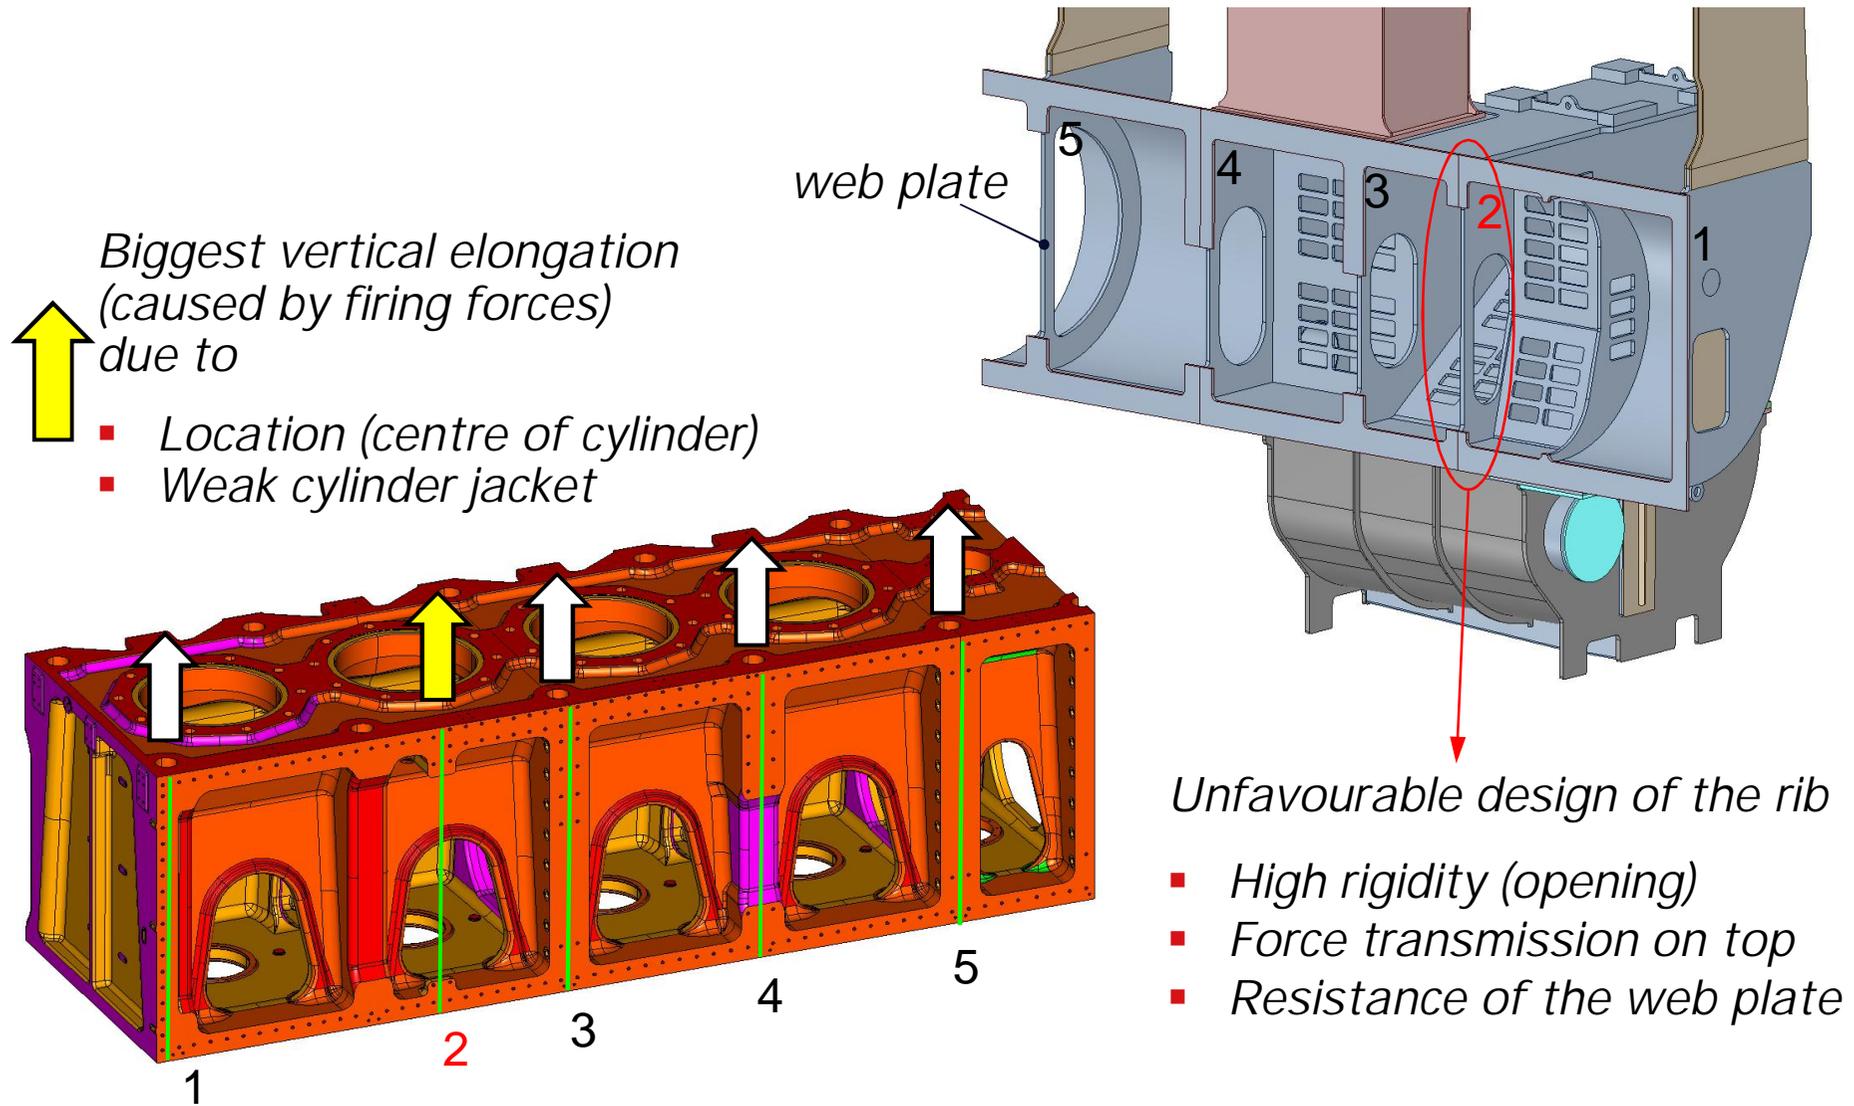
Biggest vertical elongation
(caused by firing forces)
due to

- Location (centre of cylinder)
- Weak cylinder jacket

Unfavourable design of the rib

- High rigidity (opening)
- Force transmission on top
- Resistance of the web plate

Safety not given

→ Design change needed

- *First 4 engines produced*
 - *2 ribs per engine to be modified*
 - *Smooth grinding of weld transitions*

- *New engines*
 - *Design change implemented before production*
 - *Stress release shape applied*

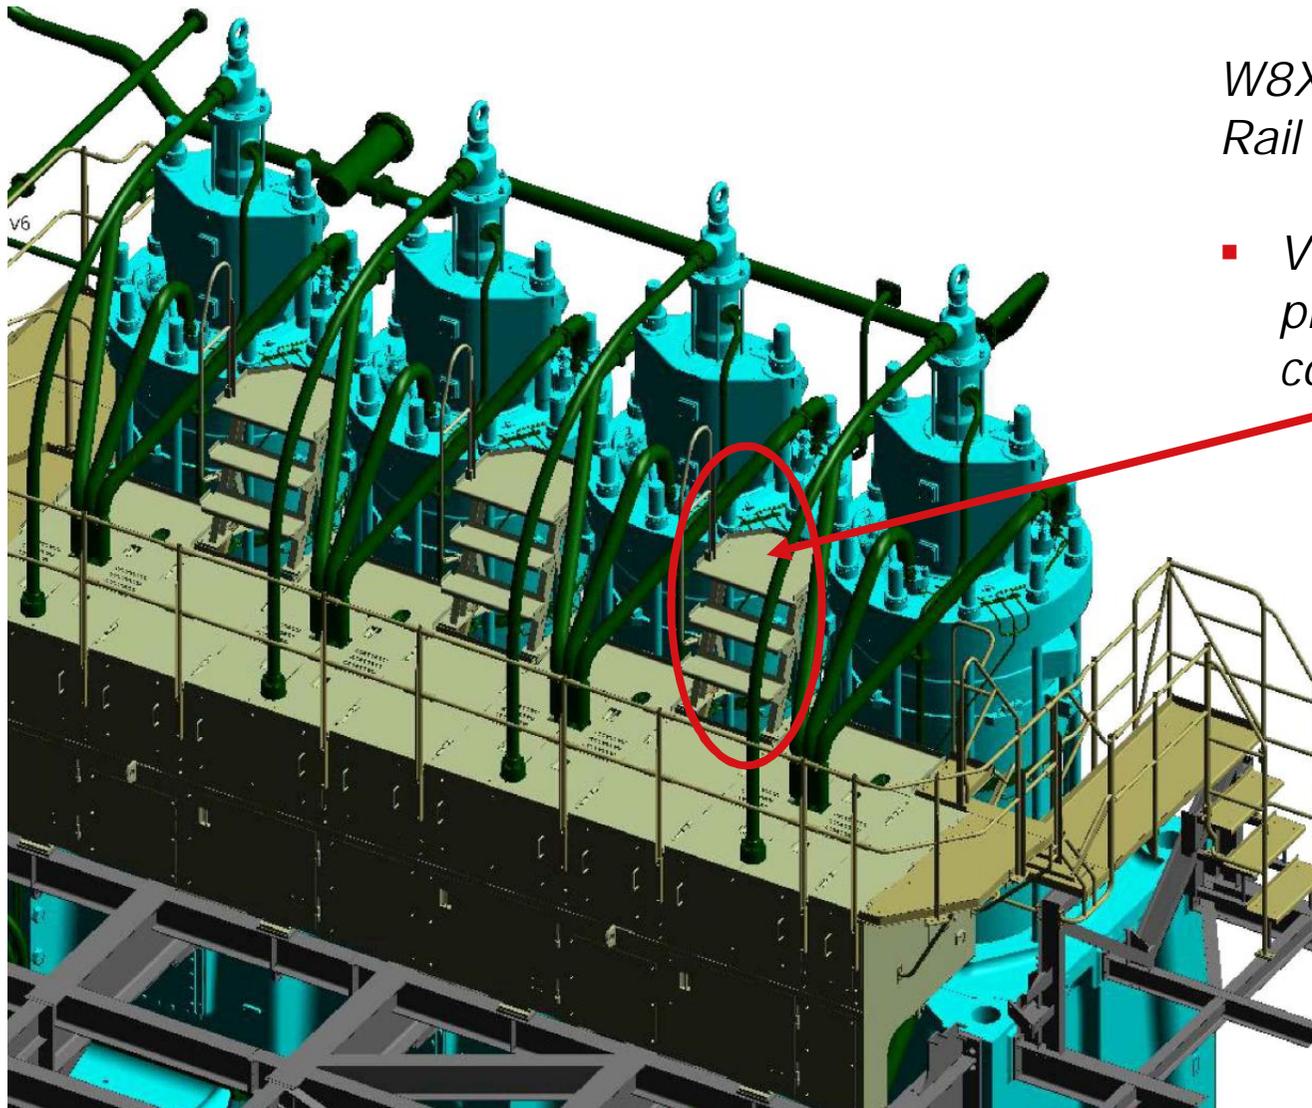
W8X92
Rail unit box

- *Vibration on inspection platform for cylinder cover*

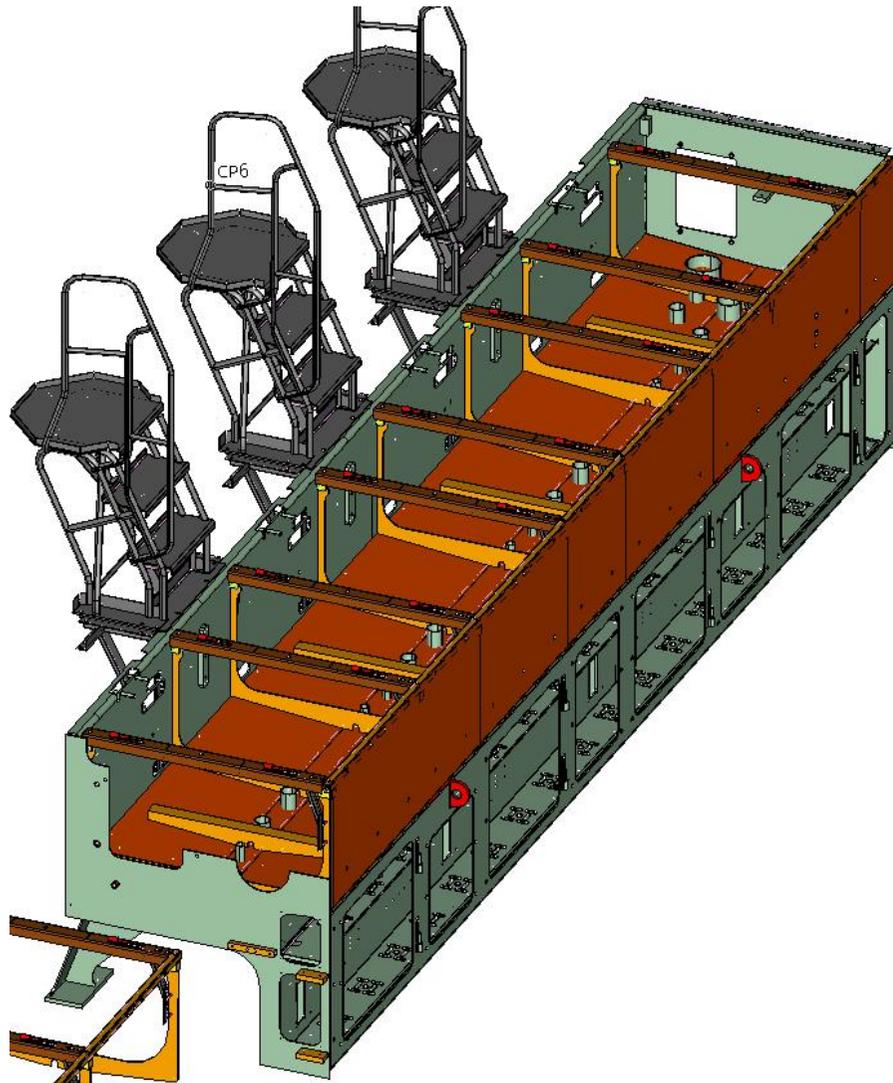
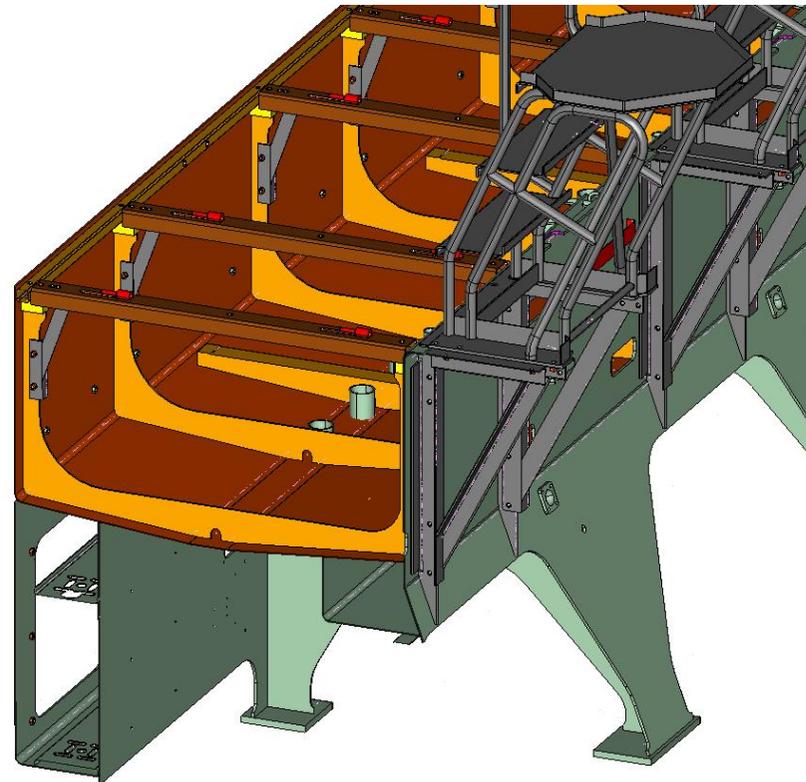
Rail unit box

✓ Reinforcement of the complete rail unit box
