Winterthur Gas & Diesel

W-X92

The most efficient Engine for large Container Vessels

W-X92, June 2016 / H. Brunner, J.-N. Constantin, L. Knipstrom

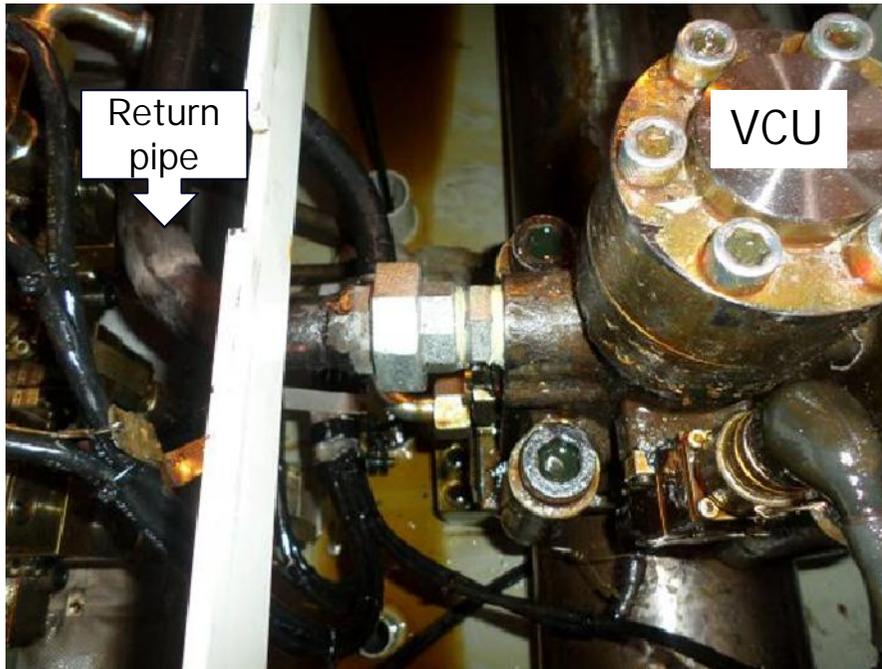
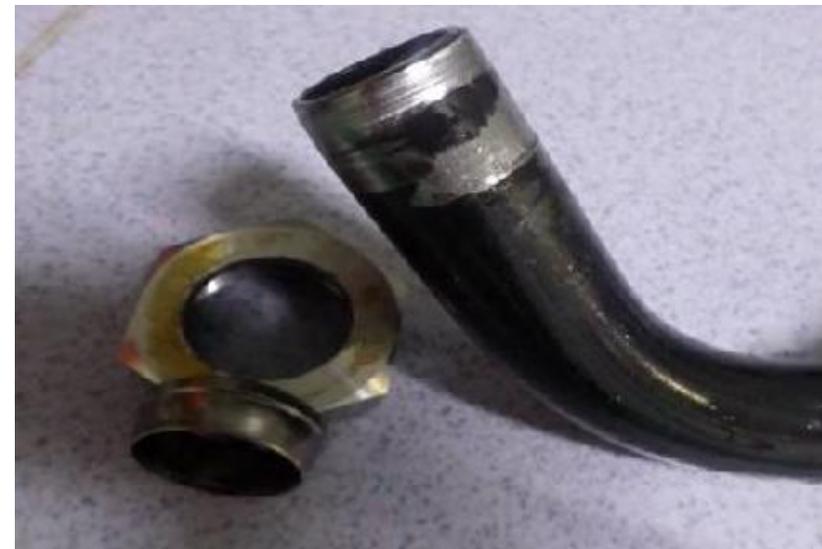
W8X92 – VCU return pipe

- Oil leakage at the connection
- Possible due to not correct pre-assembly
- Retrofit solution designed
